# DACOR BACON HOUSE HISTORIC STRUCTURE REPORT

FINAL SUBMISSION

October 2021

**BEYER  
BLINDER  
BELLE**

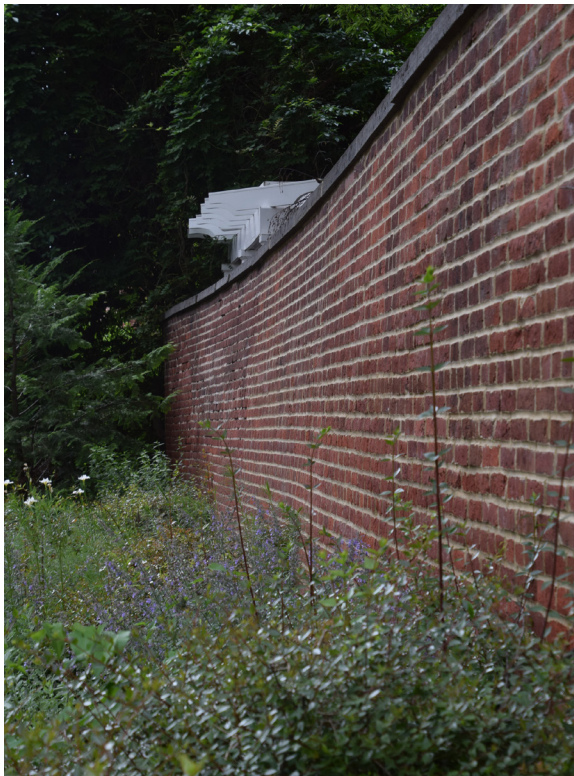
**3.93** [Left] Portion  
of the south Garden  
wall showing  
significant bowing  
and structural  
damage. [BBB]

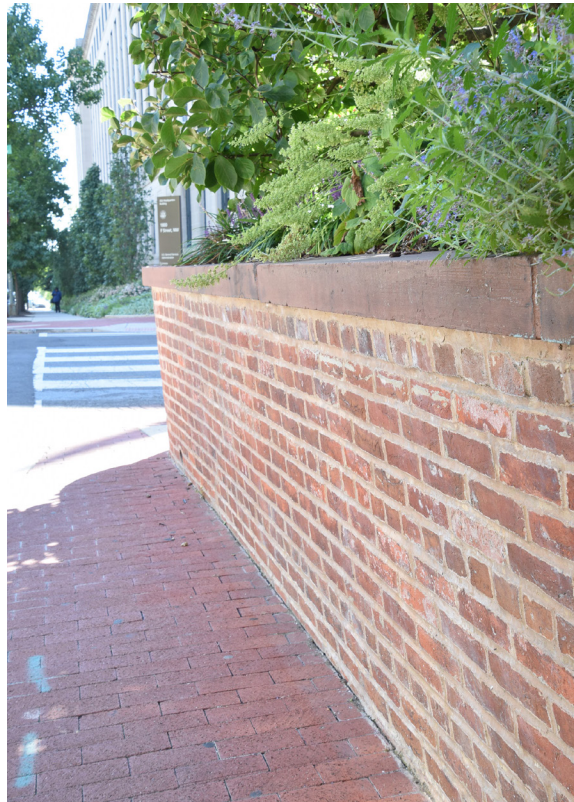
**5.2 [Top Right]** East retaining wall showing deflection from hydrostatic pressure. [BBB, 2020]

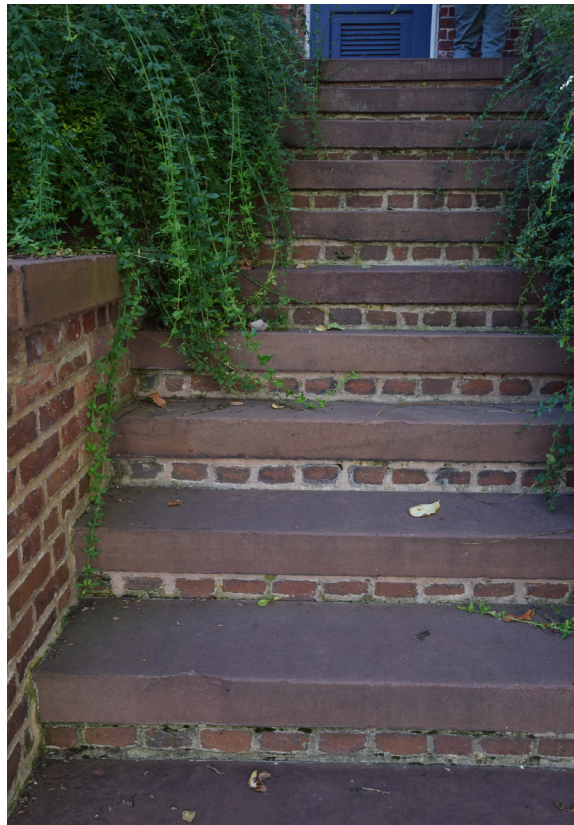
**5.5 [Lower Right]** Minor chipping at the sandstone steps on the east elevation. [BBB, 2020]

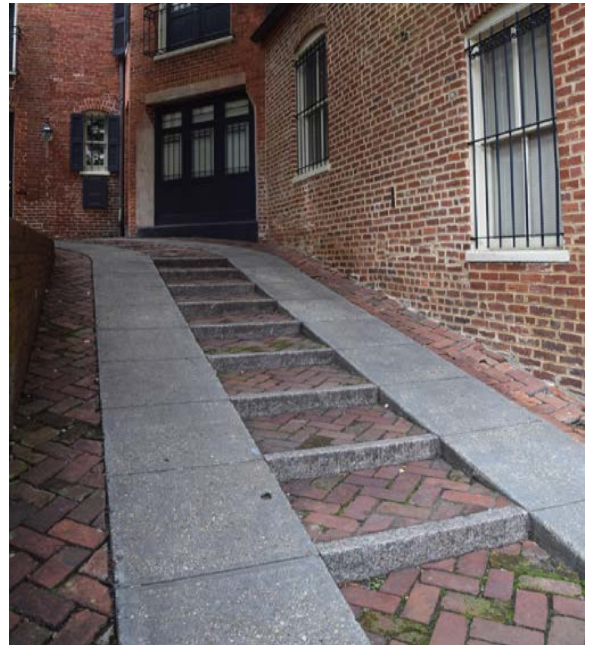
**5.17** [Top Center Left]  
The brick paving at the driveway shows minor unevenness and gaps between bricks. [BBB, 2020]

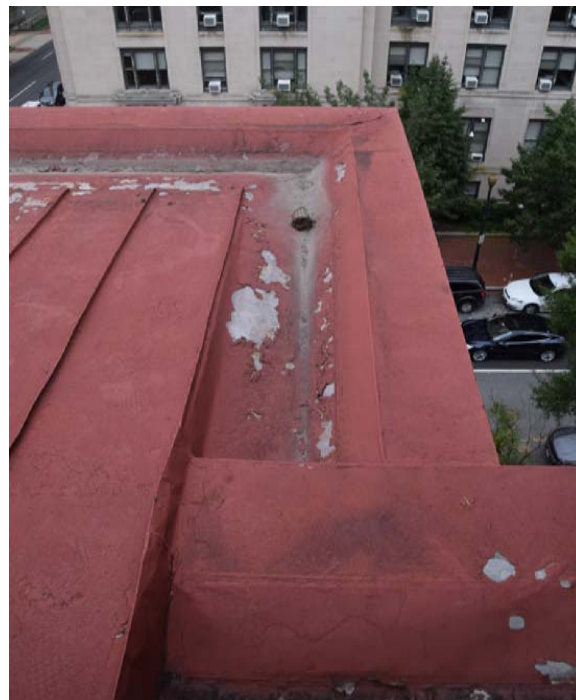
**5.25** [Lower Right] Peeling paint at roof. The strainer box at the downspout is displaced. [BBB, 2020]

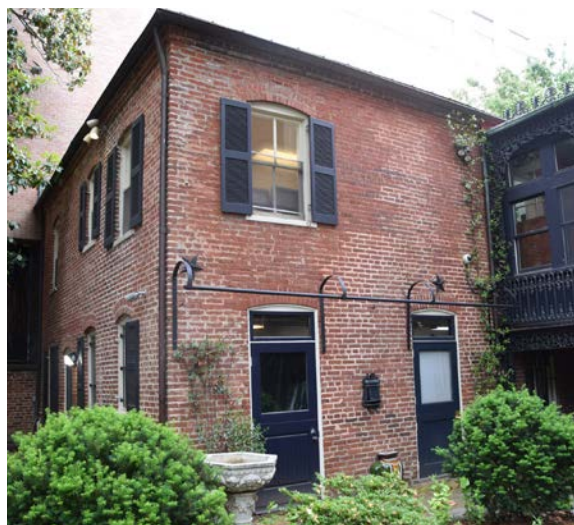
**5.46** [Right] South elevation of the Carriage House showing areas of cement mortar. The brick has various finishes resulting in a patchwork appearance. [BBB, 2020]

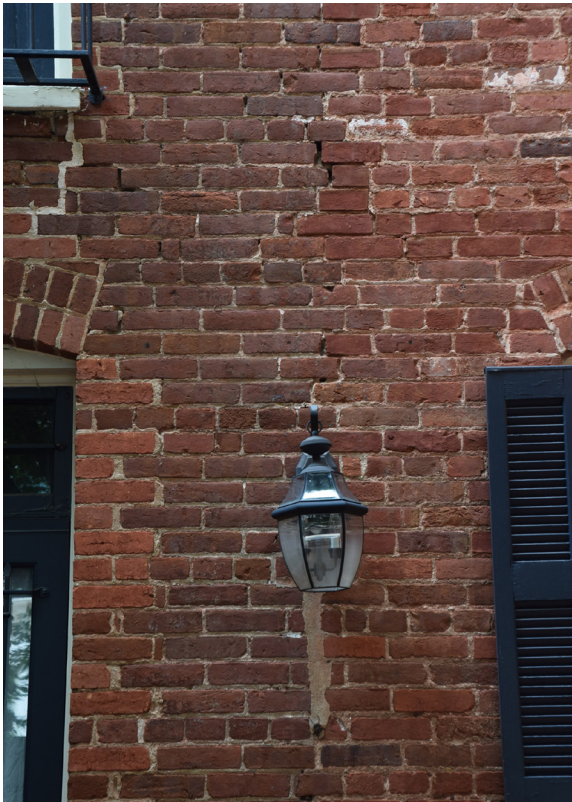
cracked and is bulging, displaced from the plane of the elevation. An inappropriate cement mortar has been used to repoint sections of the Carriage House, especially at the second-floor level on the south elevation, facing the Garden. There are a few areas that exhibit loss of mortar and will require repointing.

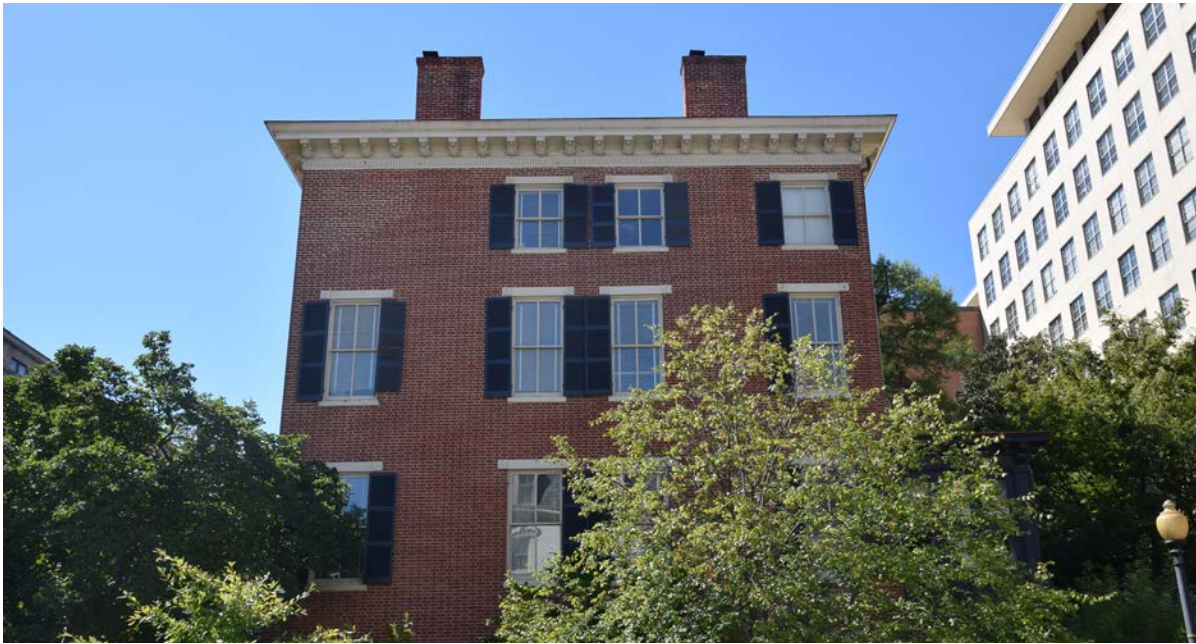
**5.52** [Center] Windows on the east elevation. Several window shutters are missing or broken. The center window at the fourth floor has shutters with three panels as opposed to two panels. [BBB, 2020]

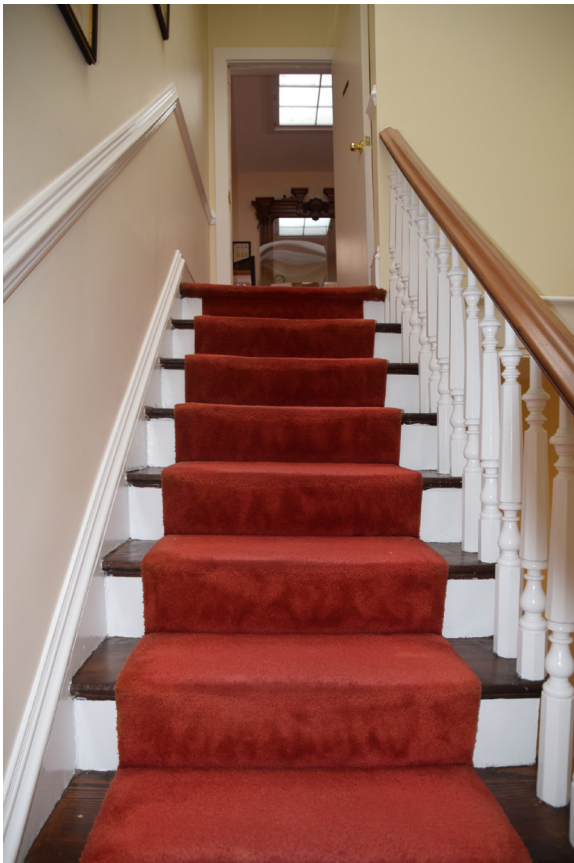
**5.82** [Lower Left]  
Deflection at main stair from half landing to fourth floor. [BBB, 2020]

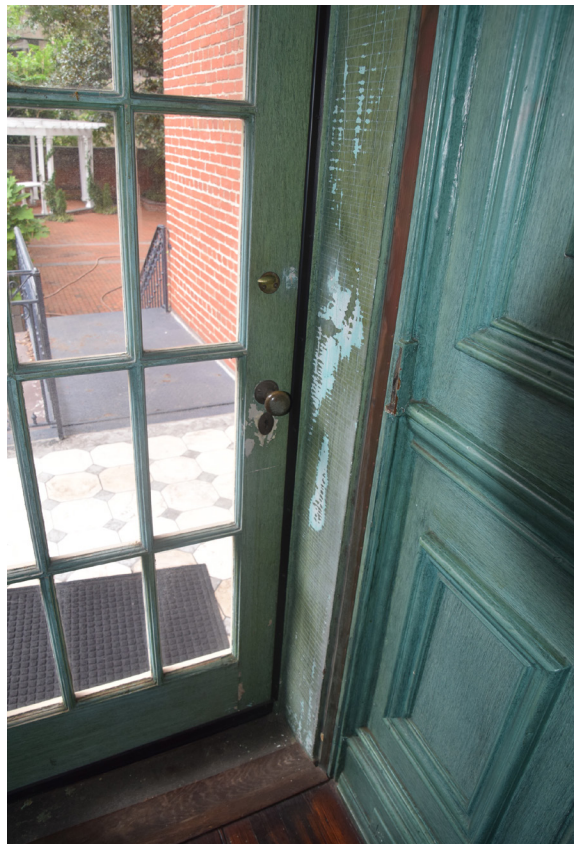
**5.90** [Top Right] Worn finish at door and door jambs to southwest porch in Garden Room on the first floor. [BBB, 2020]

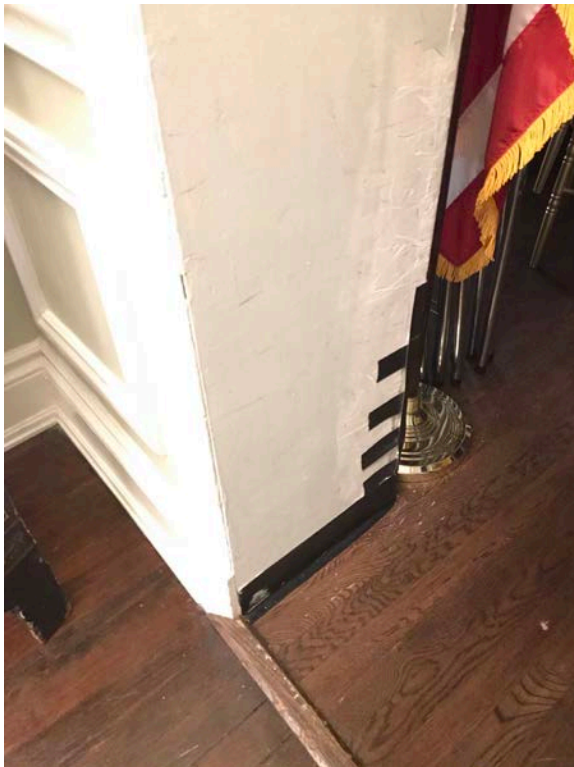
**5.91** [Center Left] Mechanical damage to door jamb between the Dining Room and storage room on the second floor. [BBB, 2020]
