Chapter 5: Existing Conditions 2024 Update

This chapter describes the existing conditions of the DACOR Bacon House as of July 2024. It is intended to be an update to the 2021 HSR condition survey, completed in October 2020, and consists of an existing condition summary matrix, a list of recommended priority treatments, condition photographs, and updated floor plans and elevations that note areas of deterioration.

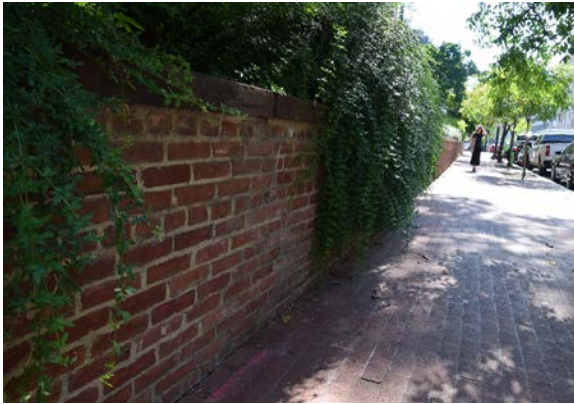
| Building/Site Element | Figures | Condition Rating | Priority Rating | Explanation/Condition Summary and Recommended Treatment(s) |
|---|--|---|---|--|
| Front Retaining Walls | Fig. 1 Fig. 2 Fig. 3 Fig. 4 | Fair | Serious (1-5 years) | Open joints at coping stones, failed or missing mortar in some locations; deflection and cracking from hydrostatic pressure as west section of wall on south façade (west of ADA ramp opening). <u>Recommended Treatment(s):</u> Repoint open joints at coping stones; repoint open joints at wall; continue to monitor lean consult landscape architect or structural engineer to consider options for monitoring and addressing deflection from hydrostatic pressure and adding reinforcement rods at areas of step cracking. |

Fig. 1 [Top Left]
Retaining wall on south façade is leaning from hydrostatic pressure. Continue to monitor. [BBB, 2024]

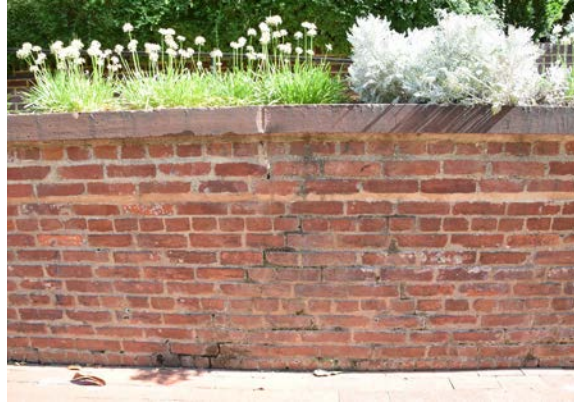
Fig. 2 [Top Left]
Retaining wall on south façade has areas that require repointing and step cracks that should be repaired. [BBB, 2024]

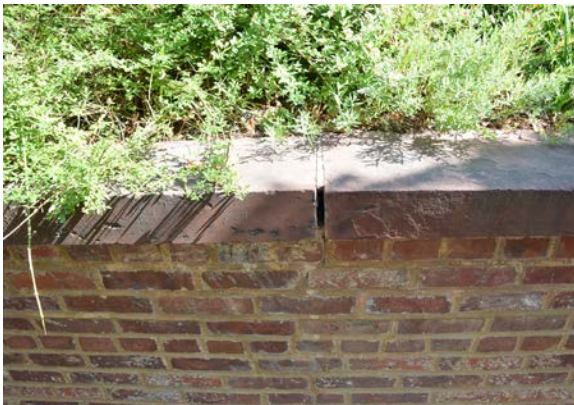
Fig. 3 [Left] Open joint at coping stone at retaining wall. [BBB, 2024]

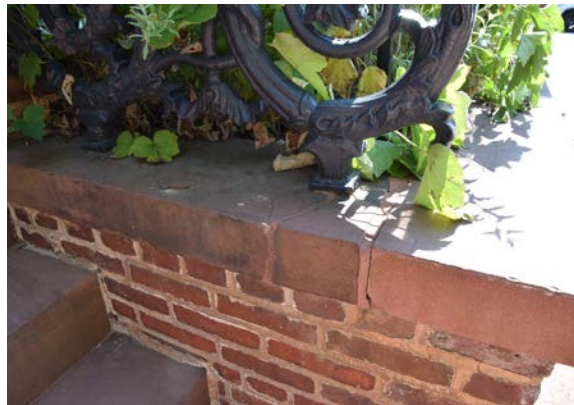
Fig. 4 [Right] Failed joint at coping stone of retaining wall. [BBB, 2024]

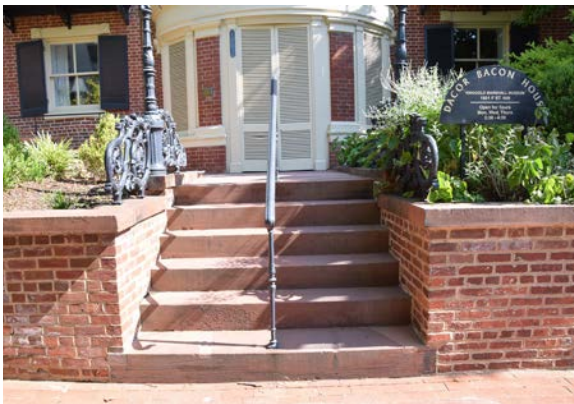
Fig. 5 [Left] Erosion and existing patches to be monitored at front steps. [BBB, 2024]

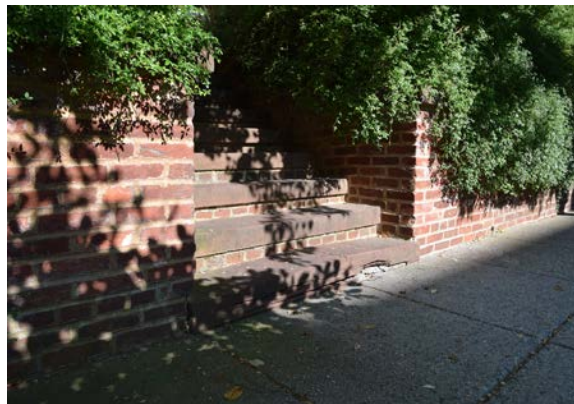
| Building/Site Element | Figures | Condition Rating | Priority Rating | Explanation/Condition Summary and Recommended Treatment(s) |
|---|--|---|---|--|
| Exterior Stairs | Fig. 5 Fig. 6 Fig. 7 Fig. 8 Fig. 9 | Fair | Serious (1-5 years) to Minor (5-10 years) | Fractured bottom stone tread at stair on east façade; deterioration of finish at iron stair handrails; deterioration of finish at metal stair to southwest porch (to Garden Room). <u>Recommended Treatment(s):</u> Replace bottom step at east stair with appropriate red sandstone replacement; strip and refinish iron railing at south entrance stair. Repair and refinish iron railing and refinish or replace metal stair at southwest porch. |

Fig. 6 [Right] Fracture crack and displacement of bottom step at east stair. [BBB, 2024]

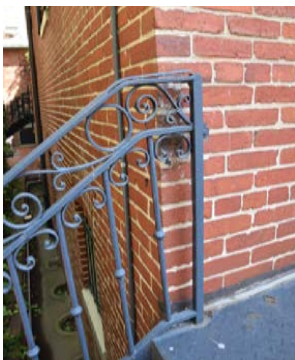
Fig. 7 [Lower Left] Split in handrail at southwest porch stair. [BBB, 2024]

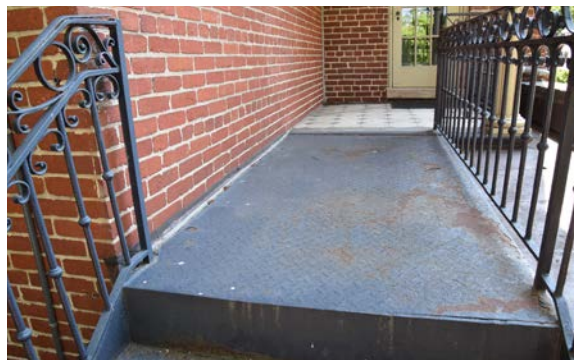
Fig. 9 [Lower Right] Deteriorated finish and corrosion at southwest stair. [BBB, 2024]

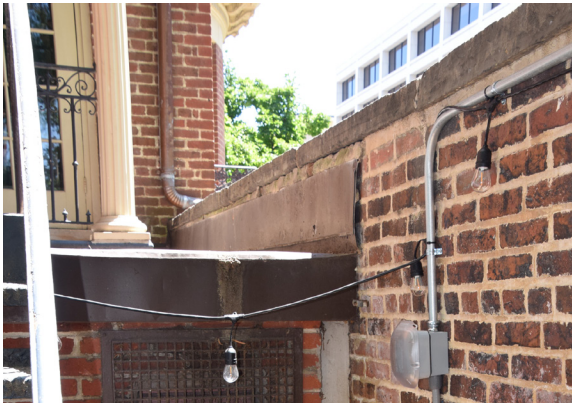
Fig. 13 [Right]
Step crack in
brick wall at ADA
entrance below
southwest porch.
[BBB, 2024]

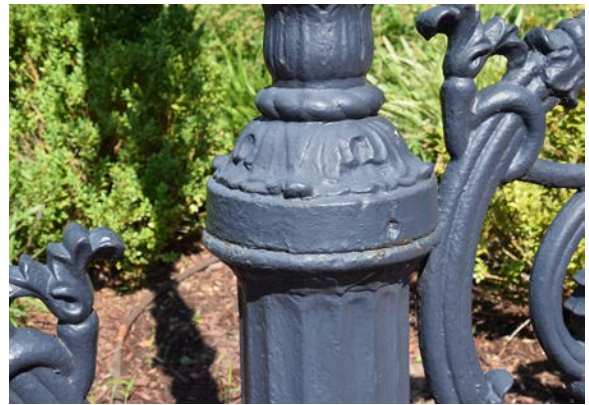
Fig. 16 [Lower
Left] Wrought iron
lantern latches
have been repaired.
Iron work should
be monitored and
spot painted as
needed. [BBB,
2024]

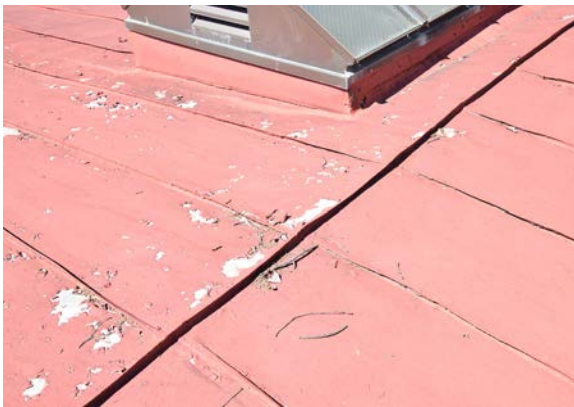
Fig. 19 [Left] Detail of roof showing deterioration of paint and flattened seams. [BBB, 2024]

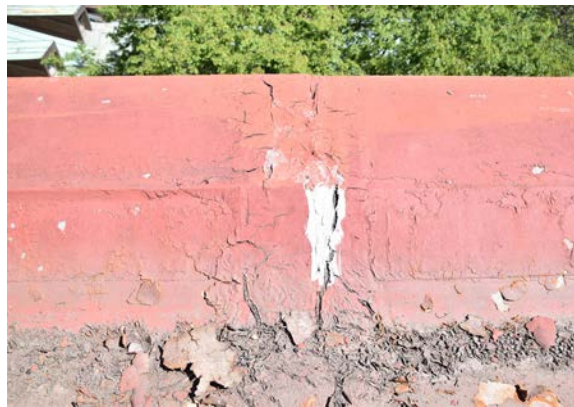
Fig. 20 [Right] Detail of roof gutter showing deterioration of sealant at joints. [BBB, 2024]

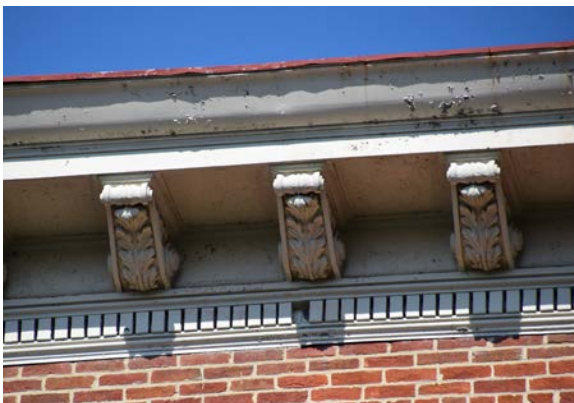
Fig. 23 [Lower Left] Deteriorated finish of cornice and missing dentil below. [BBB, 2024]

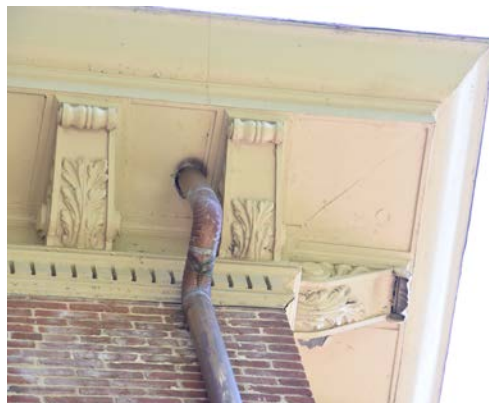
Fig. 24 [Lower Right] Deteriorated finish of cornice and missing portion of decorated corbel. [BBB, 2024]

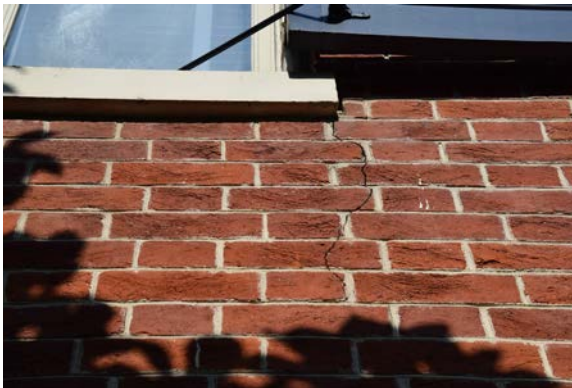
Fig. 30 [Right]
Crack above lintel
which continues as
step crack above
on east façade.
[BBB, 2024]

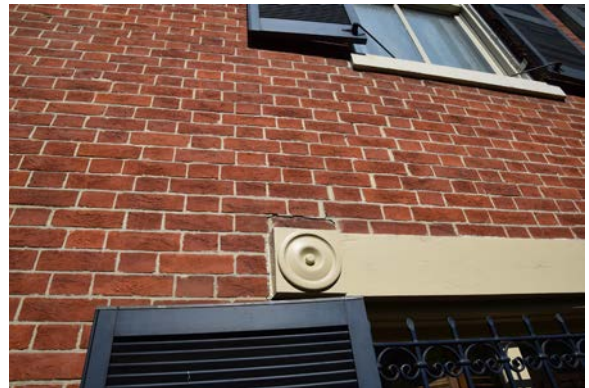
Fig. 31 [Lower
Left] Fracture
crack at lintel and
step crack above
on south façade.
[BBB, 2024]

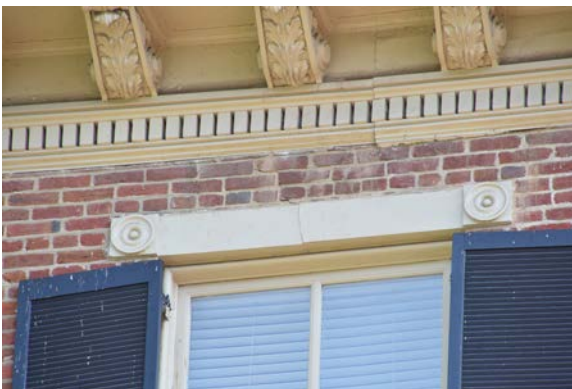
Fig. 32 [Lower
Right] Open joints
above front en-
trance bay. [BBB,
2024]

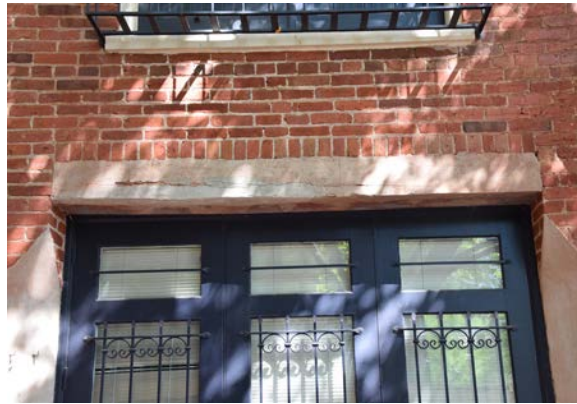
Fig. 36 [Left]
Failed patch at
lintel of Carriage
House should be
repatched with
restoration mortar.
[BBB, 2024]

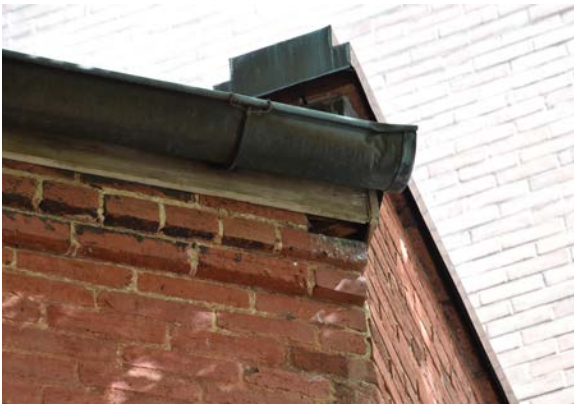
Fig. 37 [Left] Miss-
ing brick resulting
in an opening
below the gutter
on the southeast
façade of the Car-
riage House. [BBB,
2024]

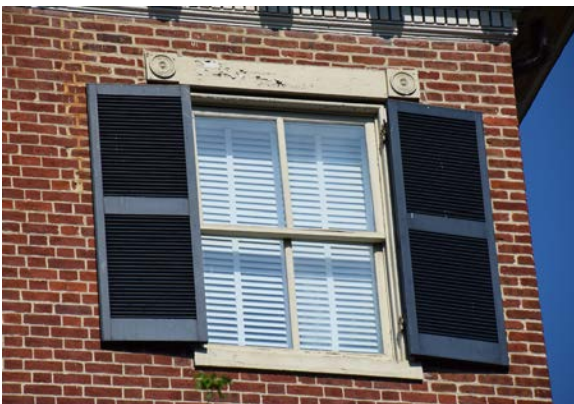
Fig. 39 [Lower
Left] Deteriorated
finish and minor
checking at the
wood window sill
and lintel on the
east façade. [BBB,
2024]

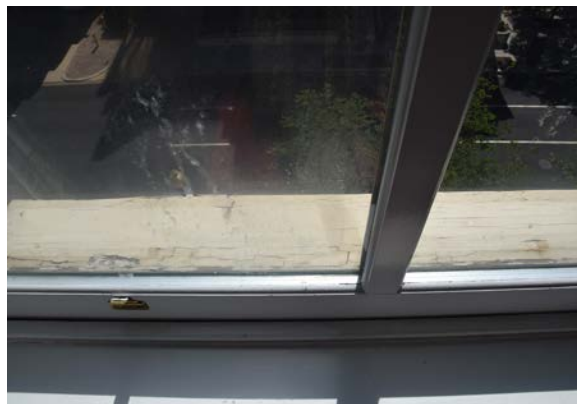
Fig. 40 [Lower
Right] Deteriorated
finish and minor
checking at wood
window sill and
fogging at glazing
of window on
east façade. [BBB,
2024]

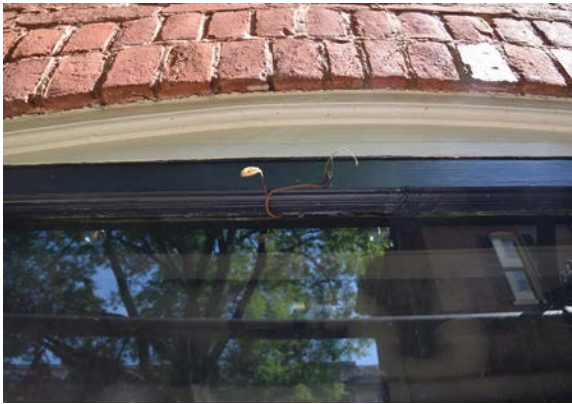
Fig. 44 [Lower
Right] Southwest
porch showing
minor deteriora-
tion of finish. [BBB,
2024]

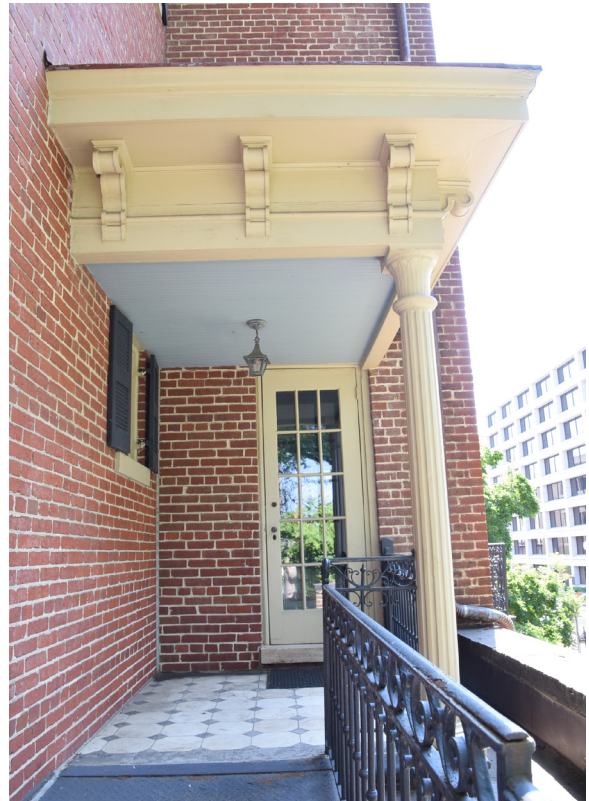
Fig. 45 [Lower
Left] North porch
showing minor
deterioration of
finish and missing/
detached window
trim. [BBB, 2024]

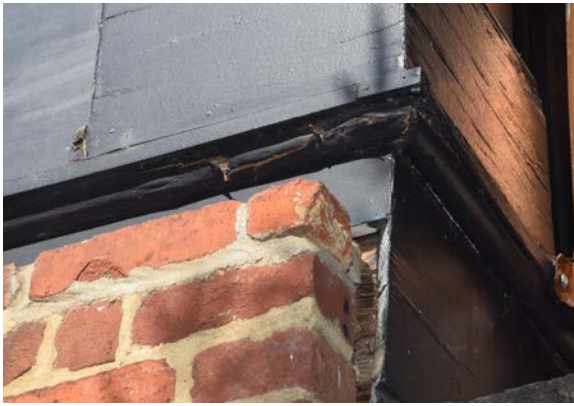
Fig. 46 [Top Left] Exposed wood beam at east façade of north porch, deteriorated finish at wood elements above. [BBB, 2024]

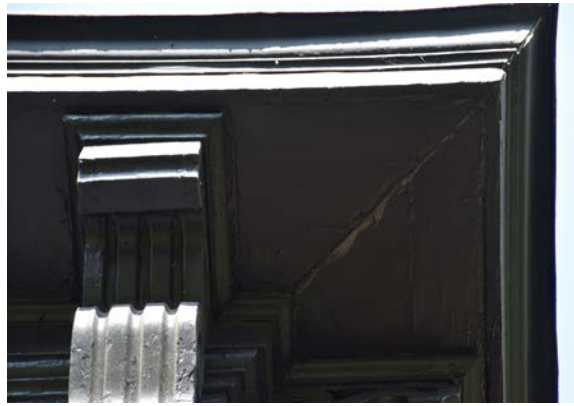
Fig. 47 [Top Right] Deteriorated finish at wood cornice of north porch. [BBB, 2024]

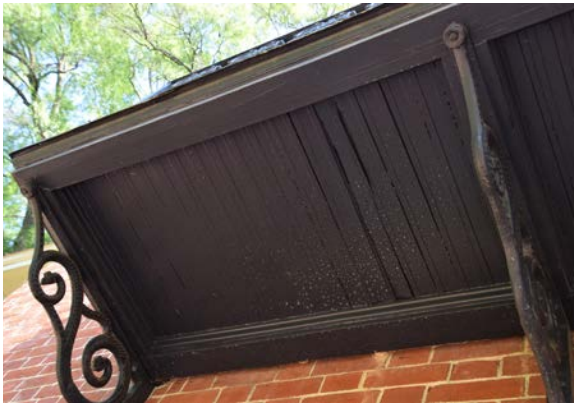
Fig. 48 [Left] Deteriorated wood boards at underside of west balcony on south façade. [BBB, 2024]

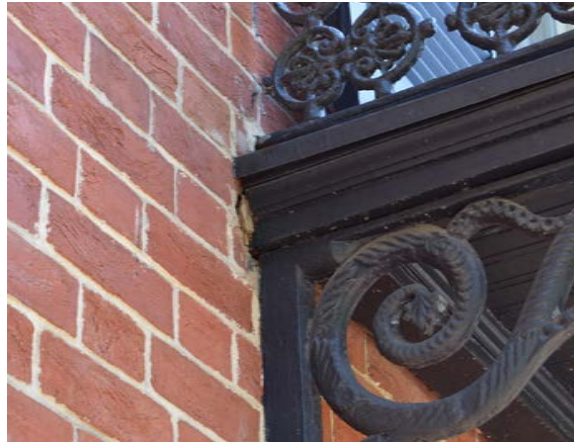
Fig. 49 [Right] Spalling brick where balcony attaches to wall. [BBB, 2024]

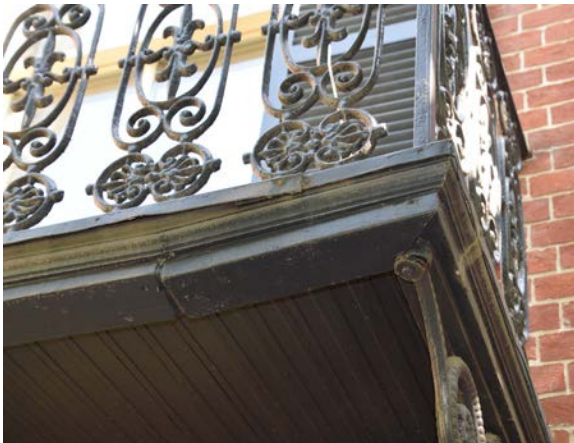
| Building/Site Element | Figures | Condition Rating | Priority Rating | Explanation/Condition Summary and Recommended Treatment(s) |
|---|---|---|---|--|
| Balconies | Fig. 48 Fig. 49 Fig. 50 | Fair | Minor | Wood framing joint on the east balcony has failed and wood boards at underside of west balcony have deteriorated. Previous patches and spalling brick at anchor points on masonry wall. <u>Recommended Treatment(s):</u> Anchor points of balconies to south façade should be inspected. Monitor wood and iron elements. Keep paint coatings in good condition to protect these materials. Repair failed joint at underside of west balcony. |

Fig. 50 [Lower Left] Separating joint at frame of east balcony on south façade. [BBB, 2024]

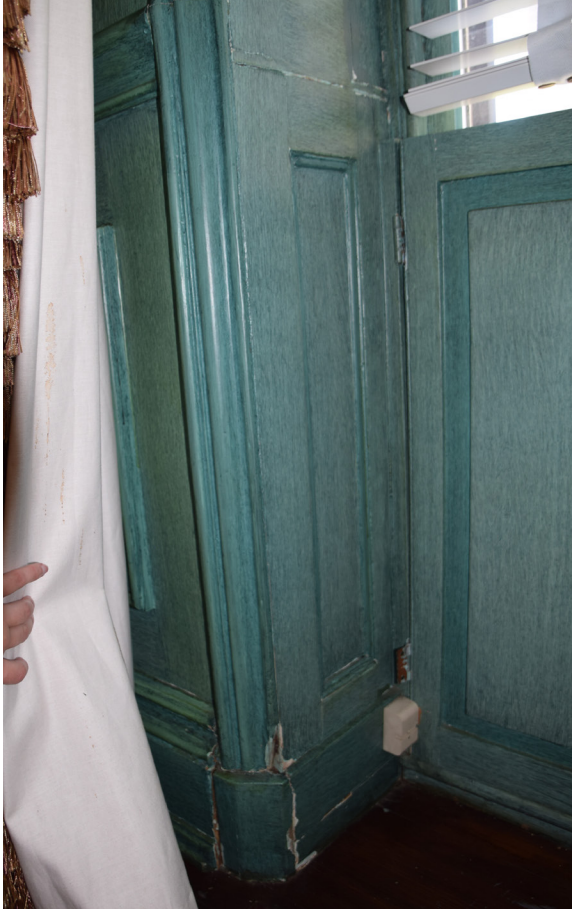
Fig. 55 [Lower Right]
Garden Room corner showing vertical crack, which has been painted.
[BBB, 2024]

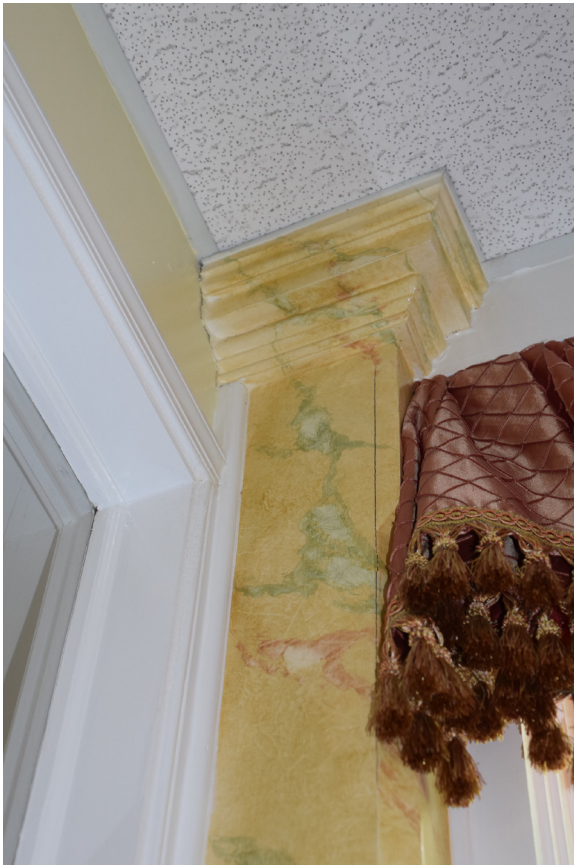
Fig. 56 [Top Left]
Hairline cracks at
corners of Gallery
pilasters. [BBB,
2024]

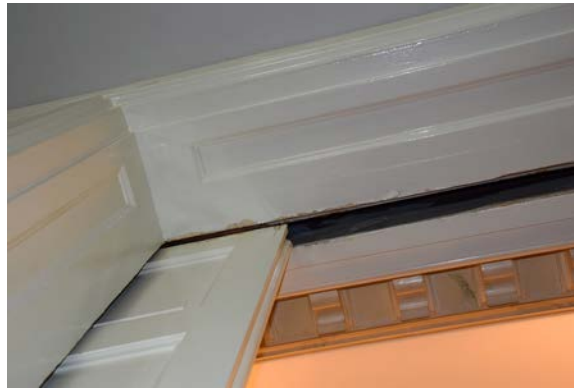
Fig. 57 [Top Right]
Deteriorated finish
and signs of wear
at pocket door
opening on second
floor. [BBB, 2024]

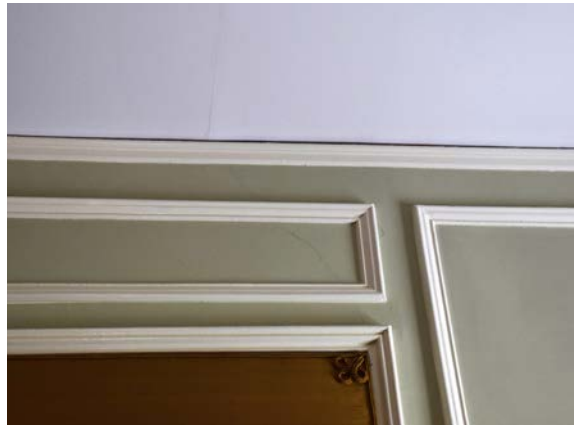
Fig. 58 [Right]
Hairline crack in
plaster ceiling and
wall panel in North
Parlor. [BBB, 2024]

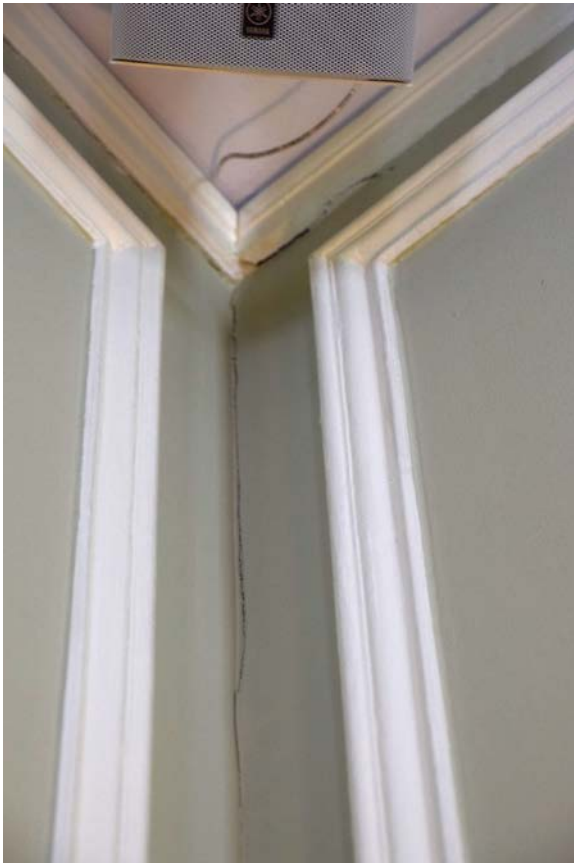
Fig. 59 [Lower
Left] Separation at
crown molding and
vertical crack at
northwest corner
of South Parlor.
[BBB, 2024]

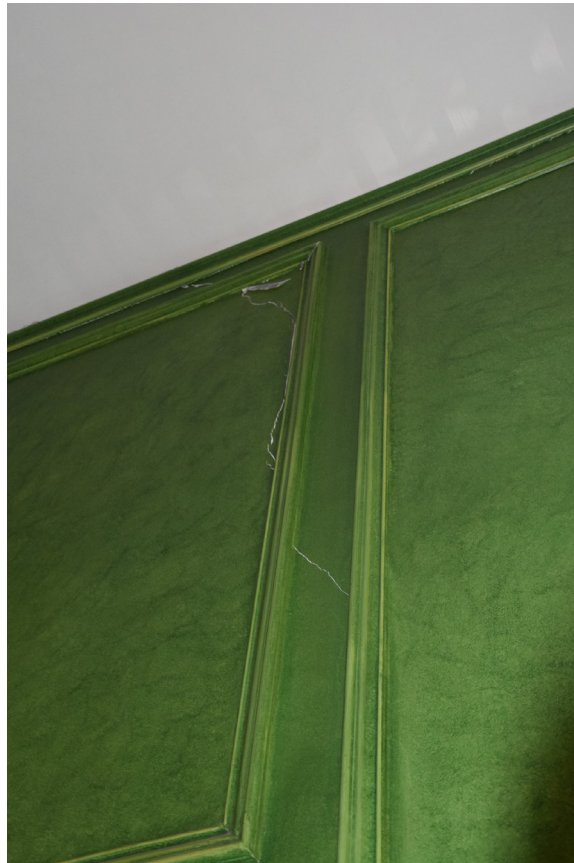
Fig. 60 [Lower
Right] Large crack
on east wall of
Grand Stair Hall.
[BBB, 2024]

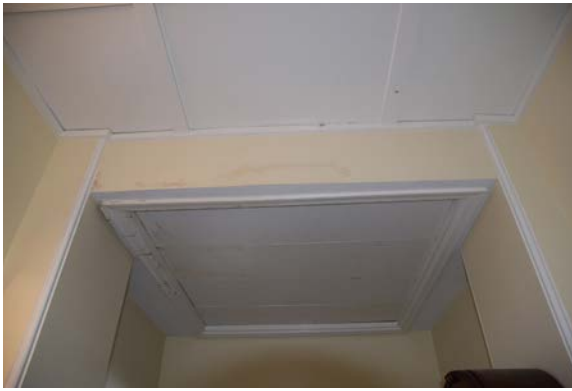
Fig. 62 [Top Right]
Bubbling of ceiling
finish in Grand
Stair Hall. [BBB,
2024]

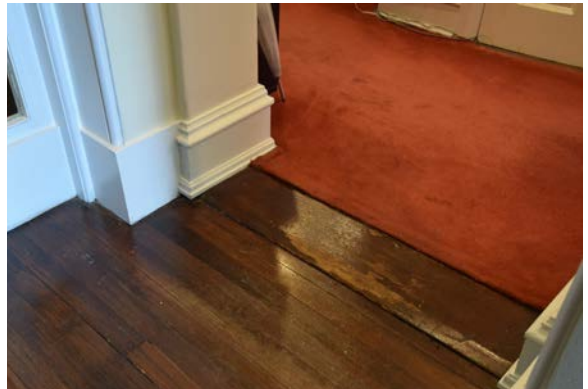
Fig. 65 [Bottom
Left] Worn finish
at wood floors in
Dining Room.
[BBB, 2024]

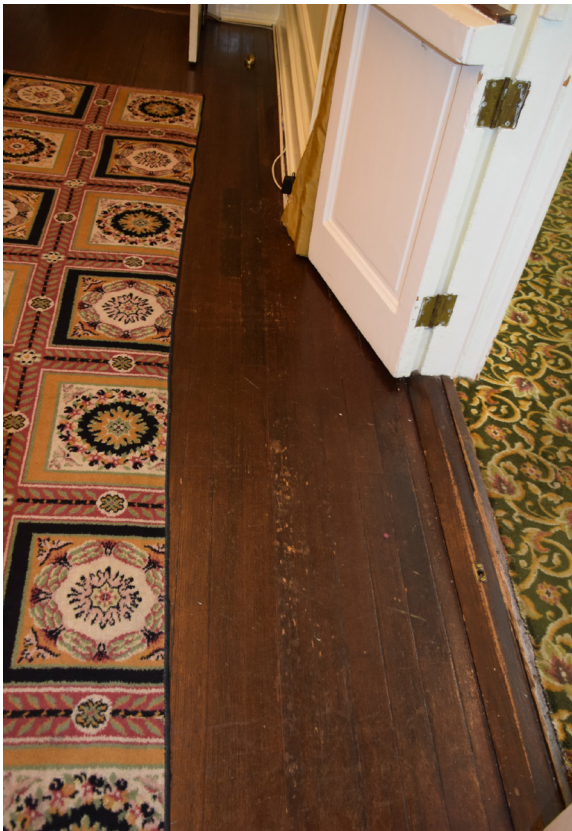
Fig. 66 [Bottom
Right] Newly
installed Tangier
Legation door sits
in the floor of the
Meeting Room.
[BBB, 2024]

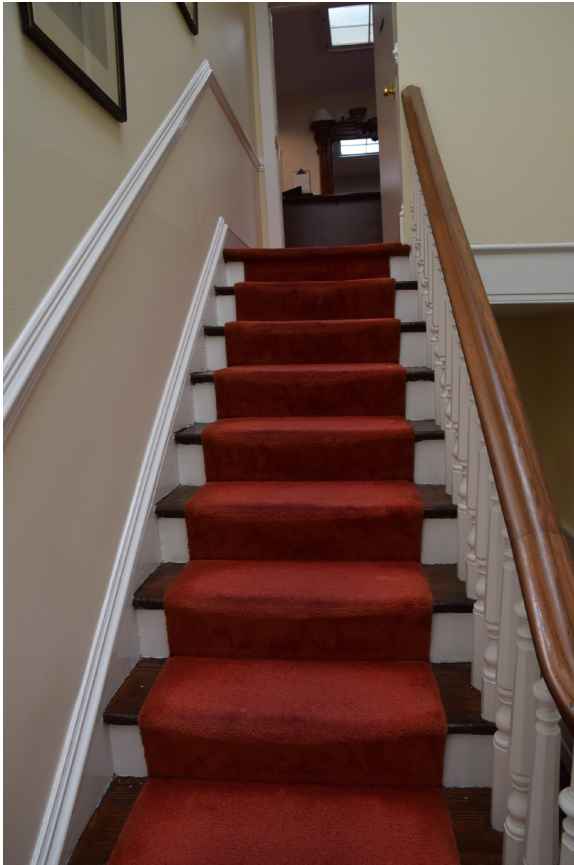
Fig. 67 [Top Left]
Stair conditions ascending to fourth floor. Stairs slope slightly away from wall and should be monitored. [BBB, 2024]

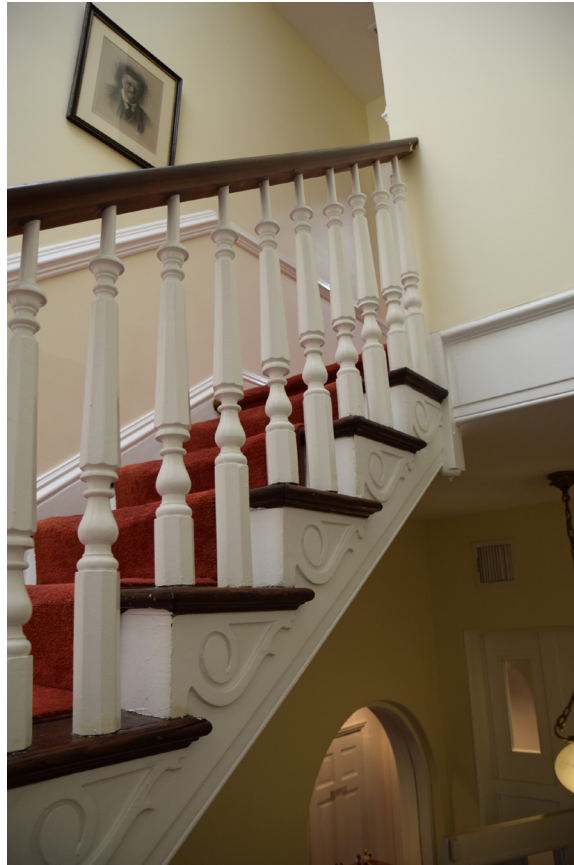
Fig. 68 [Top Right]
Outer stair conditions ascending to fourth floor. Split stair nosing in lower left corner and overpaint on tread above [BBB, 2024]

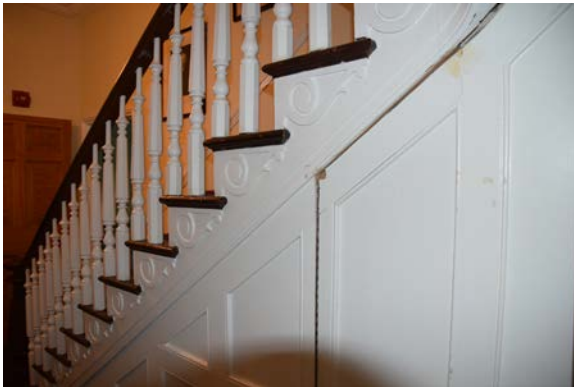
Fig. 69 [Left]
Panel below stair cut to allow access to heat pump [BBB, 2024]

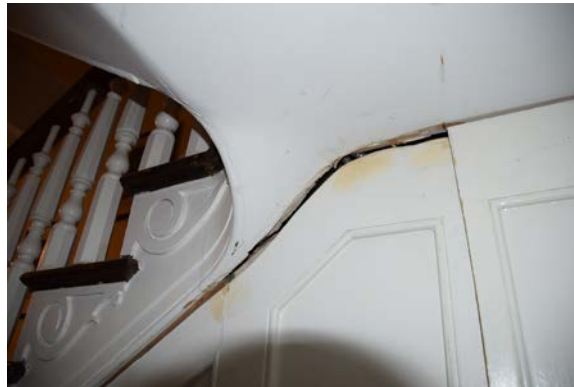
Fig. 70 [Right]
Underside of stair and panel below stair to be repaired. [BBB, 2024]

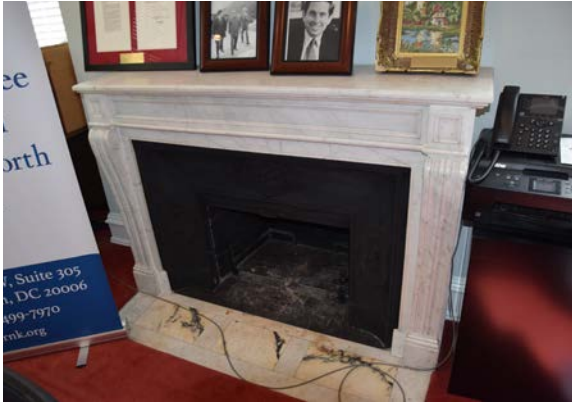
| Building/Site Element | Figures | Condition Rating | Priority Rating | Explanation/Condition Summary and Recommended Treatment(s) |
|---|---|---|---|---|
| Fireplaces | Fig. 71 Fig. 72 | Fair | Minor | <p>Overall good condition. Settlement of third floor northeast office fireplace. Minor cracking or gouging at corners at other locations.</p> <p><u>Recommended Treatment(s):</u> Continue to monitor and address settlement at third floor fireplace.</p> |

Fig. 72 [Top Left]
Cracked hearth bricks of fireplace in northeast office on third floor; functional hearth screen. [BBB, 2024]
