# DACOR BACON HOUSE HISTORIC STRUCTURE REPORT

FINAL SUBMISSION

October 2021

**BEYER  
BLINDER  
BELLE**

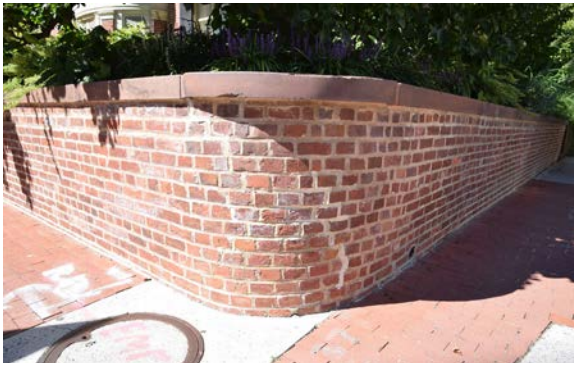
Hydrostatic pressure has resulted in deflection and cracking at the walls over time. The deflection was mitigated with the insertion of additional weep holes in the masonry. Cracking, especially at the corner of F and 18th Streets, has been routinely repaired by repointing. The coping stones exhibit weathering and stone deterioration, including scaling, fracturing, and cracking in addition to soiling and biological growth. It appears that two types of stone have been used and one is more prone to fractures and cracks. Skyward facing cracks have been filled with restoration mortar.

**5.1 [Top Left]** Southeast corner of the retaining wall showing signs of step cracking, repair, and repointing. [BBB, 2020]

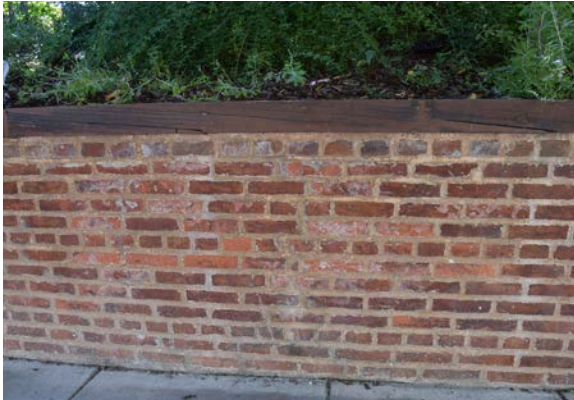
**5.3 [Top Center Left]** East retaining wall showing cracking along the bedding planes of the sandstone coping stones. [BBB, 2020]

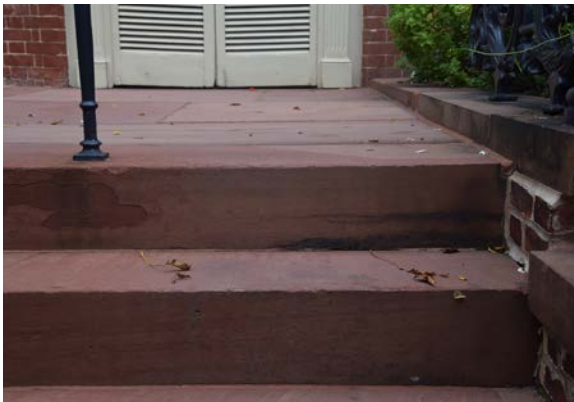
The south and east steps leading up to the House exhibit peeling and chipping of the stone masonry. The south steps have been patched with restoration mortar,

**5.4 [Lower Center Left]** Sandstone steps at south entry exhibit scaling, past repairs, and cracking along the bedding planes. [BBB, 2020]

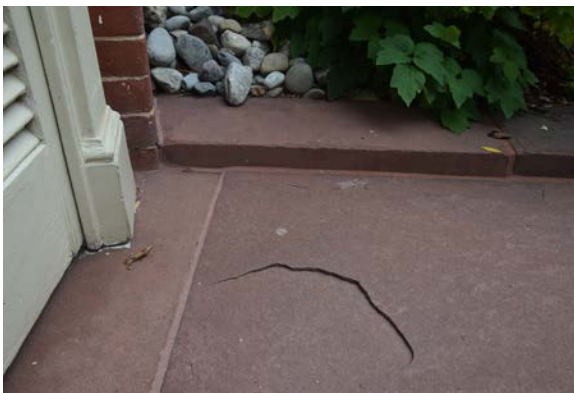
**5.6 [Lower Left]** Sandstone paving stone at front entrance has scaled and blistered, leading to detachment of the stone. [BBB, 2020]

detached stone layer should be ground/tooled down to sound stone. Additionally, the mortar joints between the paving stones have detached in some areas and should be monitored. The brick paving at the west side of the semi-circular entrance bay exhibits biological growth from excess water ponding in the area surrounding the bay's downspout. This condition may be remedied by addressing the cause of the excess water collecting there, which likely occurs when water overflows from the bay's roof. The downspout may be undersized or blocked with debris.

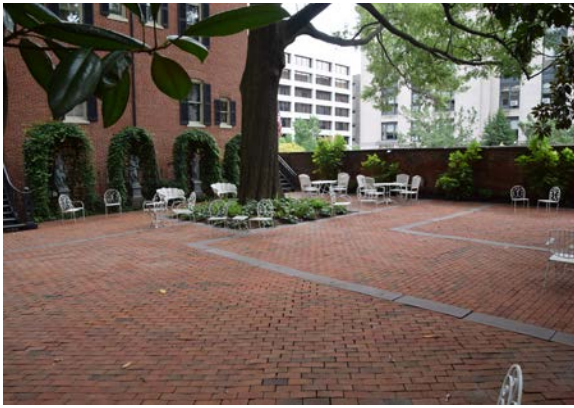
**5.12** [Top Left] Brick paving stones in the Garden exhibit minor unevenness. [BBB, 2020]

The brick and slate paving throughout the Garden is in good to fair condition. Several bricks are missing at the raised platform in the southwest corner below the pergola. There are areas of minor unevenness along Garden paths and in the main open space due to settlement and lifting from roots and other ground movement. The paving is power washed regularly to remove soiling and biological growth.

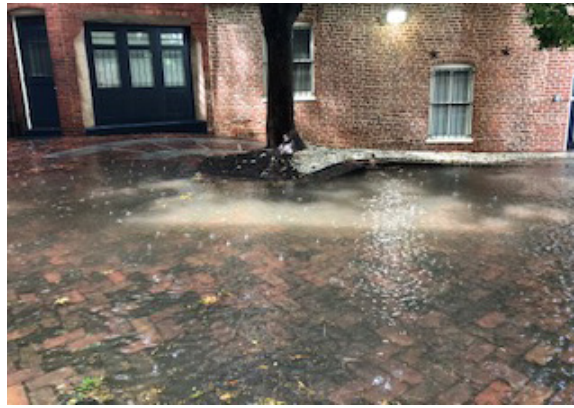
**5.13** [Right] Photo of flooding in the courtyard during a heavy rain. [DA-COR Bacon House, 2020]

The courtyard also has issues with drainage and is prone to flooding during large downpours. Dirt and debris is then left at the center of the courtyard and the bottom of the wood fence, which encloses the cooling tower and trash collection area at the west. The fence is susceptible to wood decay from the pooling water.

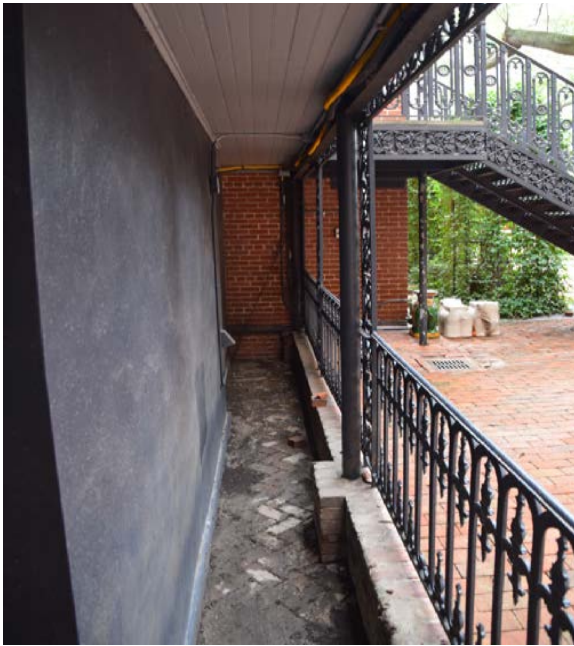
**5.14** [Lower Left] Dirt and debris from rain have washed into the areaway below the porch/breezeway. This is evidence of poor drainage within the Garden. [BBB, 2020]

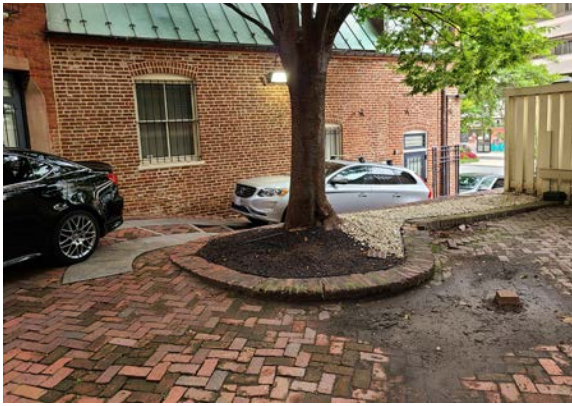
**5.15** [Top Left]  
Dirt and debris from rain have washed into the courtyard, surrounding the drain. [BBB, 2020]

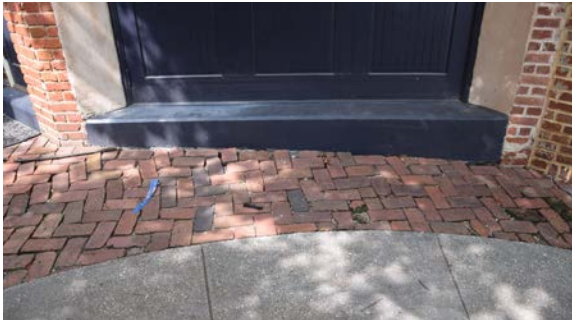
The brick and concrete driveway is in good to fair condition, and the brick retaining wall is in good condition. There are areas of unevenness and gaping at the brick

**5.17** [Top Center Left]  
The brick paving at the driveway shows minor unevenness and gaps between bricks. [BBB, 2020]

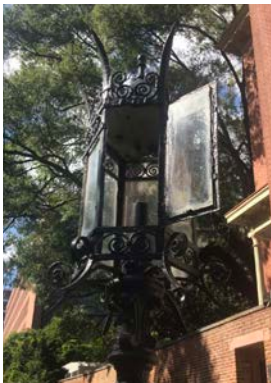
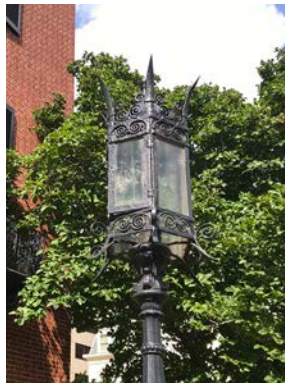
**5.18** [Lower Center Left]  
Left: West wrought iron lamppost fixture at the south entrance is missing a bulb and the glass panel does not latch closed. Right: East wrought iron lamppost fixture. [BBB, 2020]

Historic cast- and wrought-iron light posts and railings, dating to the mid-nineteenth century, frame the south steps leading to the main entrance. The fixtures are in fair condition. There is no active corrosion, but the iron does have an uneven surface texture, which may indicate there is past corrosion below the painted surface. The glazed panel doors of the lamp shade do not latch shut.

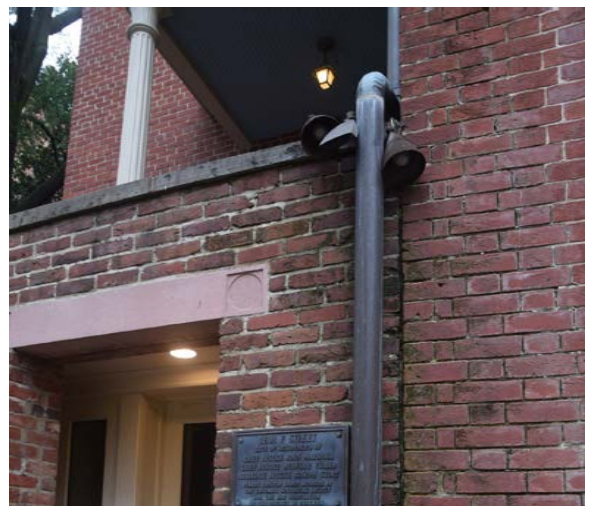
**5.19** [Lower Right]  
Multiple spotlights near business entrance appear to be redundant. [BBB, 2020]

lighting fixtures appear at the rear of the Carriage House, facing the Garden, and within the courtyard. Spotlight style fixtures are also used as well as more traditional lantern-style fixtures at the courtyard entrance. While the majority of lights appear to function, fixtures are inconsistent, aesthetically inappropriate, and may be redundant.

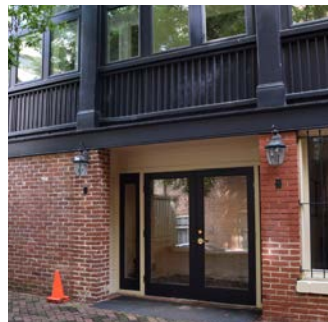
**5.20** [Lower Left]  
Left: Emergency light fixtures at Carriage House. Right: More traditional looking light fixtures at courtyard entrance to the House. [BBB, 2020]

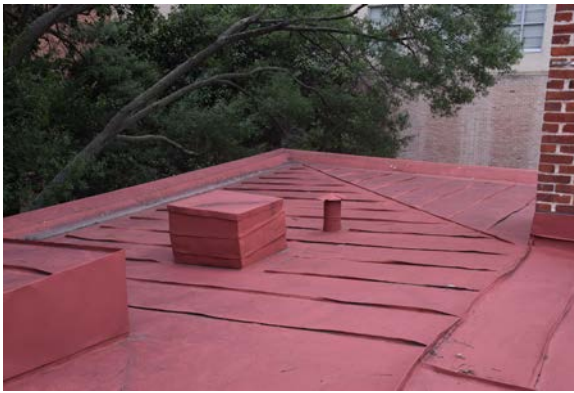
**5.21** [Top Left] Northwest corner of the House roof, looking northwest. Standing seams have been flattened. [BBB, 2020]

The standing-seam terne-coated steel roof of the House is in poor condition. The seams are uneven and have been flattened in many cases. The paint coating

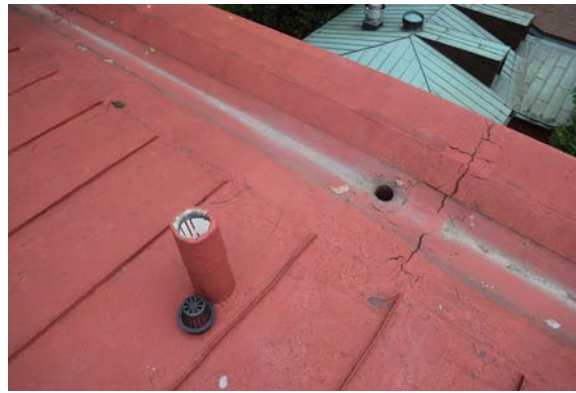
**5.22** [Top Right] Roof coating is peeling and cracking. The small downspout opening is missing a strainer box. [BBB, 2020]

is peeling, crazing, and cracking, exposing the metal below. This is especially true at the gutter and edges that cover the metal cornice below. Four four-inch downspouts serve the approximately 2,800 square foot roof. Strainer boxes have become dislodged, are missing, or are blocked with debris.

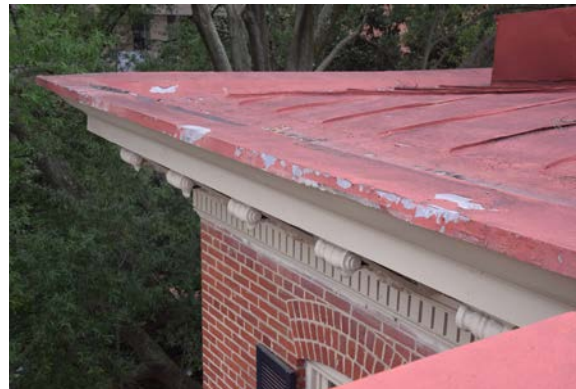
**5.24** [Center Right] Peeling paint on the roof flashing that protects the overhanging cornice. [BBB, 2020]

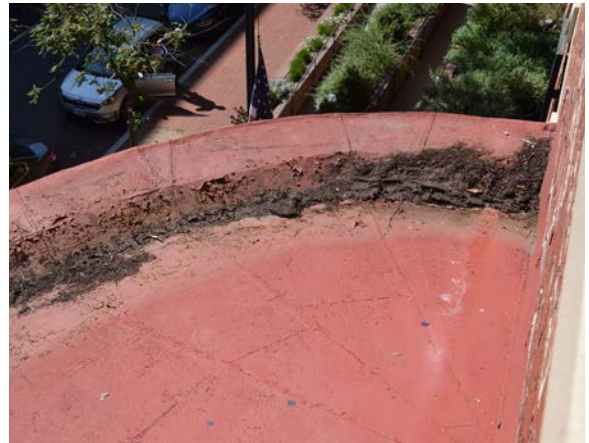
**5.27** [Top Right]  
Gutter at the entrance bay roof is clogged with debris and the roof exhibits peeling paint. [BBB, 2020]

The roof at the semi-elliptical entrance bay also exhibits its peeling and crazing of the coating. The gutter and downspout at the west corner is clogged with debris. Other flat, coated roofs at the north porch (Gallery) and New Orleans porch appear to be in good condition; however, these roofs were not accessed for a close

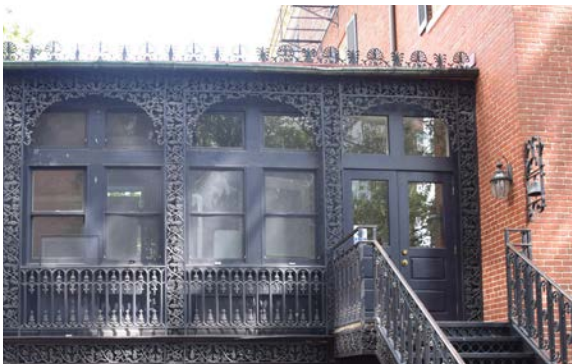
**5.30** [Lower Left]  
New Orleans porch/breezeway exhibits a displaced copper gutter at the right. [BBB, 2020]

inspection. The copper gutter at the west side of the New Orleans porch is bent above the door and stair to the Garden and should be repaired.

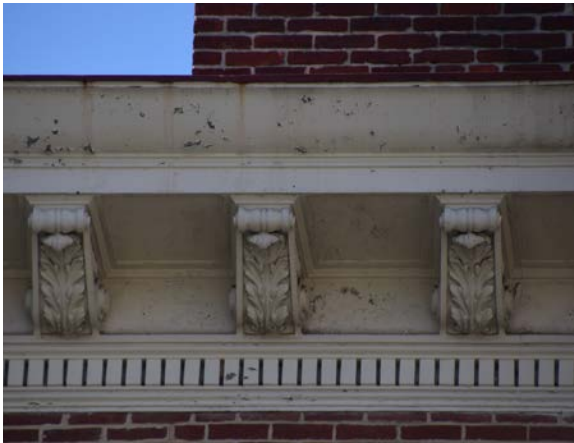
The painted metal cornice at the House is in fair condition. It exhibits peeling paint, minor corrosion, and lifting/displacement from the brick masonry. A piece of acanthus leaf decorating the cornice modillions is missing at the southwest corner. The downspout at the southwest corner of the building was dislodged from the cornice; however, it was replaced in February 2021. Water saturation at the masonry walls in this location will therefore be relieved. The remaining one downspout on the west elevation and two on the north elevation appear to be in fair condition. A section of

**5.31** [Top Left] Peeling paint and iron staining at the galvanized sheet metal cornice, [BBB, 2020]

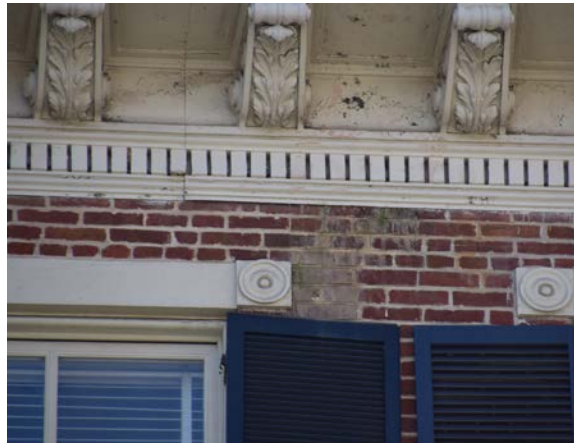
**5.32** [Top Right] The galvanized sheet metal cornice exhibits peeling paint and lifting from the masonry. There is also some staining and soiling on the brick masonry below. [BBB, 2020]

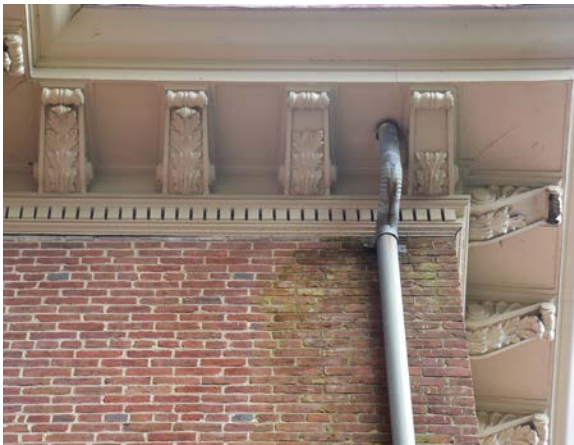
**5.33** [Center Left] Previous southwest downspout showing displacement from the gutter at the overhanging cornice causing deterioration and biological growth to the masonry below. This downspout was replaced in 2021. [BBB, 2020]

The previously displaced downspout at the southwest corner of the building has resulted in biological growth, loss of mortar, and staining from water along the west elevation above the southwest porch. The downspout

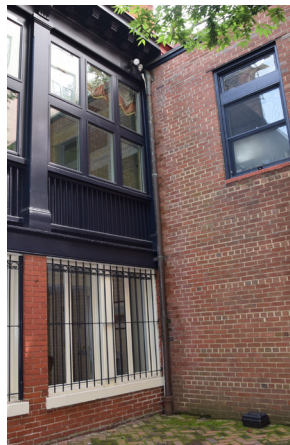
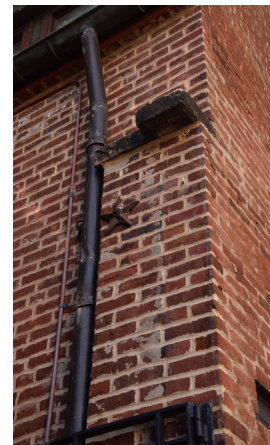
**5.34** [Lower Right] Left: previous northwest downspout at the north porch has split at the seams causing excess water saturation of the masonry at the corner. It was replaced in 2021. Left: southeast downspout at the Carriage House is dented in areas. [BBB, 2020]

downspout on the north elevation that was leaking at the seams was also replaced in February 2021. Downspouts at the Carriage House are in good to fair condition, exhibiting minor dents and weathering.

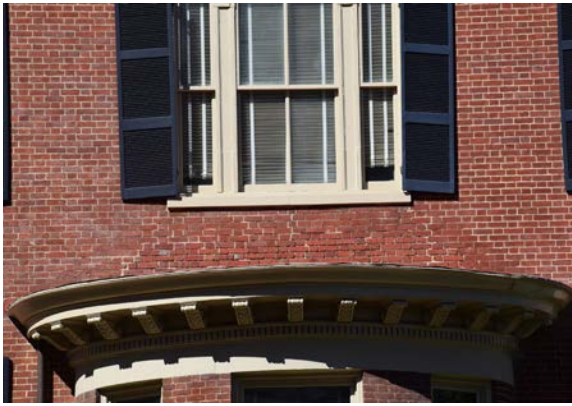
**5.36** [Top Left] Masonry above the entrance bay exhibits missing mortar and step cracking from the corners of the tripartite window, above. [BBB, 2020]

was replaced in February 2021. Loss of mortar and step cracking appears above the entrance bay and below the tripartite window on the south façade. The interior facing piers at the first floor of the entrance bay also exhibit loss of mortar, where the binder of the mortar has been lost and what remains is fine, powdery sand. The east joint between the entrance bay and the south façade is partially open at the entablature above the first floor. The Seneca red sandstone water table and other decorative embellishments at the entrance bay have been coated with an unknown paint. The stone substrate shows evidence of erosion and delamination, resulting in missing pieces and loss of detail. Active stone decay is present at the east corner. The coating is encouraging this decay by trapping moisture in the stone and surrounding brick masonry.

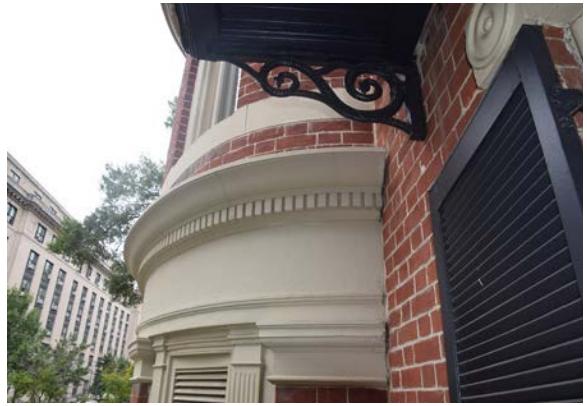
**5.37** [Top Right] Joint at east side of the entrance bay and the south facade is open. [BBB, 2020]

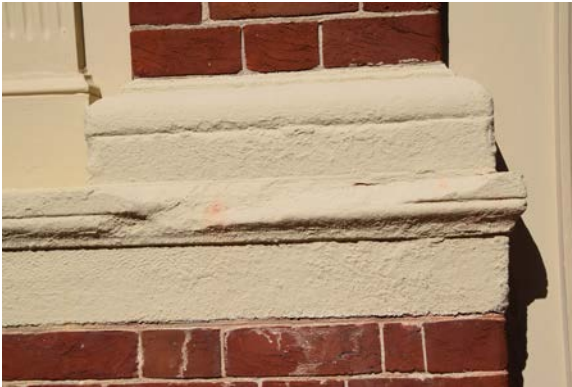
**5.38** [Lower Left] Red sandstone sill course at the entrance bay exhibits erosion and has been painted, causing water to become trapped within the stone and leading to further deterioration. [BBB, 2020]

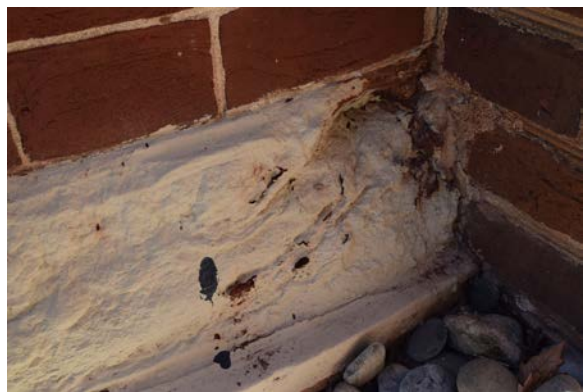
**5.39** [Top Center Right] Red sandstone sill course at the east side of the entrance bay exhibits erosion. [BBB, 2020]

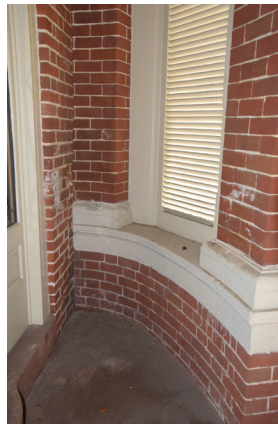
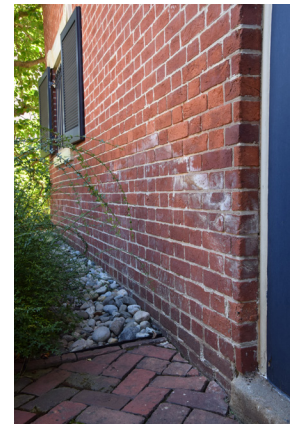
**5.40** [Lower Center Right] Left: Efflorescence at the inside face of the entrance bay. Right: Efflorescence on the east elevation. [BBB, 2020]

Moisture is also present at the interior of the entrance bay. Efflorescence, from salts dissolved in water that move through the masonry piers, appears at the east side of the bay. The French drain installed along the perimeter of the east elevation and the southeast corner of the south façade has reduced the amount of moisture in the adjacent walls. A line of efflorescence is visible

showing the extent of previous rising moisture. Moisture in these areas is no longer a concern, but should be monitored. The efflorescence may be brushed from the brick with a stiff natural or synthetic bristle brush.

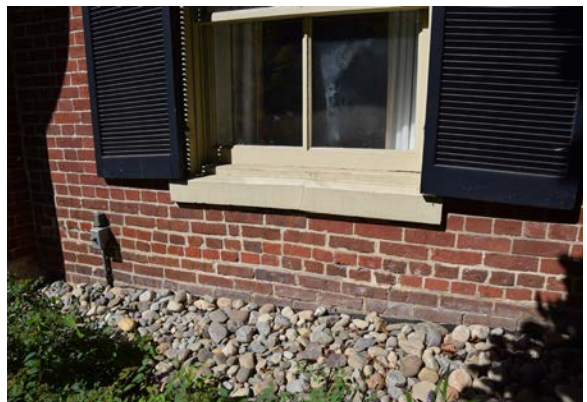
**5.41** [Lower Right] Uneven courses below the first floor windows and a fracture crack at the stone lintel. [BBB, 2020]

There is evidence of settlement in some areas, especially at the first floor of the south façade where the brick courses below the first floor windows are uneven and there is some deflection and cracking at the right window sill and below. There is also deflection at the lintels of the center tripartite window on the third floor and the paired window on the fourth floor.

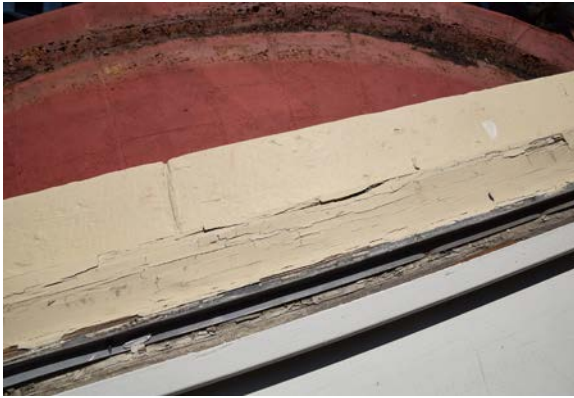
**5.50** [Top Left] Checking and peeling paint at the third floor tripartite window sill and frame on the south elevation. [BBB, 2020]

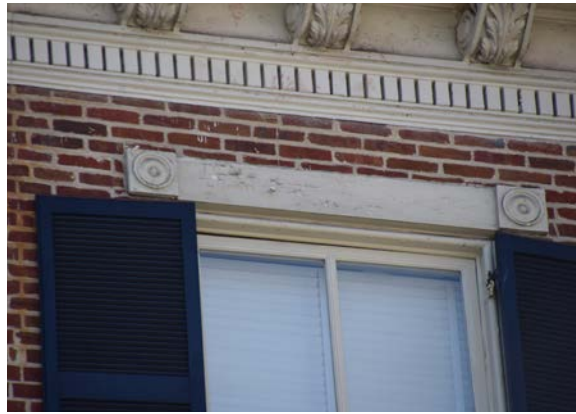
**5.51** [Top Right] Checking and peeling paint at the fourth floor window lintel on the east elevation. [BBB, 2020]

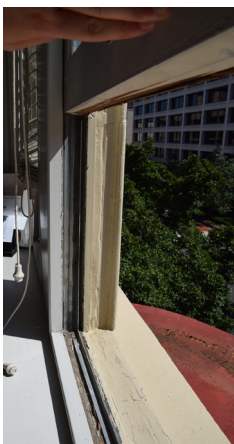
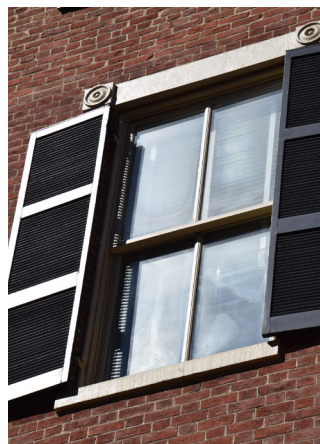
**5.53** [Left] Left: Uneven texture at the window frame from overpaint and checking at the bottom rail of the frame. Right: many window panes present a cloudiness, indicating that the window seal has failed. [BBB, 2020]

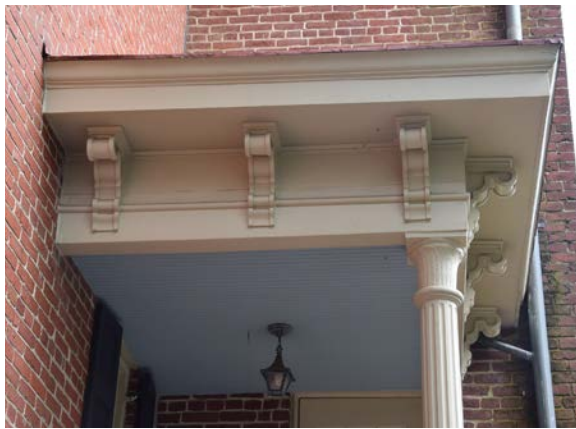
The porch at the southwest corner shows some cracking and uneven texture at the entablature and there is loss of detail at the column capital. The metal flashing

**5.59** [Top Left] Southwest porch exhibits cracking at the frieze and loss of detail from over-paint, especially at the column capital. [BBB, 2020]

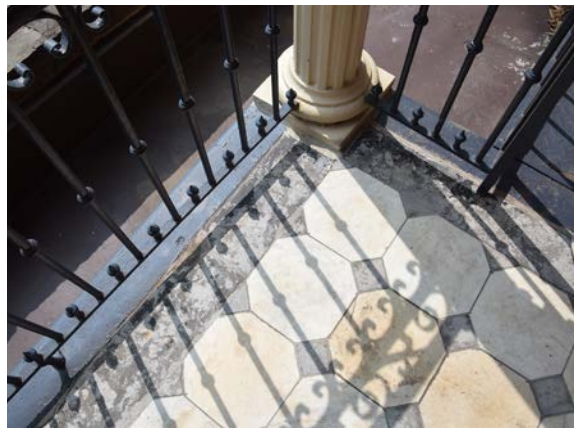
**5.60** [Top Right] Minor staining of marble flooring at southwest porch. [BBB, 2020]

covering the cornice is lifting and shows signs of deterioration. The marble flooring shows some staining and weathering, but is in overall good condition. The metal stair has some areas of corrosion at the handrail, platform, and steps.

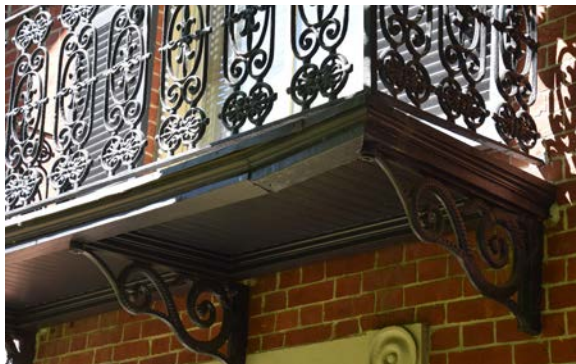
**5.61** [Center Left] Split wood member at east balcony on the south elevation. [BBB, 2020]

A wood framing piece supporting the east balcony at the first-floor window on the south facade has failed. The iron work at the balconies is in good condition. The iron work at the New Orleans porch is also in good condition. Portions of the wood edge at the original wood flooring have broken or are missing.

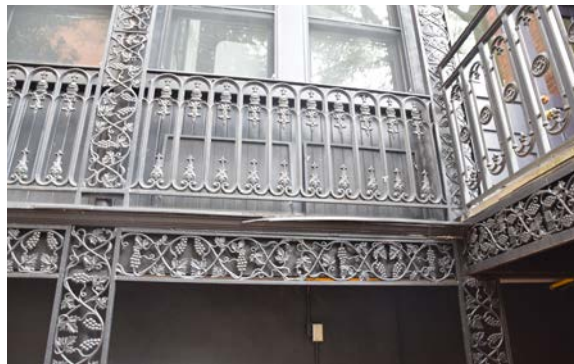
**5.62** [Center Left] Edging strip at New Orleans porch is split and pulling away. [BBB, 2020]

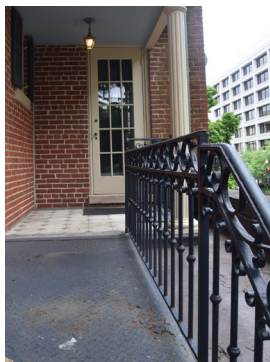
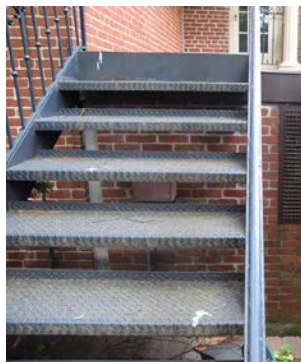
**5.63** [Lower Left] Left: Metal railing and platform at southwest porch exhibits corrosion. Right: Metal steps also exhibit corrosion. [BBB, 2020]

Two sets of exterior stairs provide access from the second floor of the House to the Garden. The stair at the southwest porch has a platform that extends to the edge of the west wing. The stair and railing is in fair condition and exhibit minor corrosion.

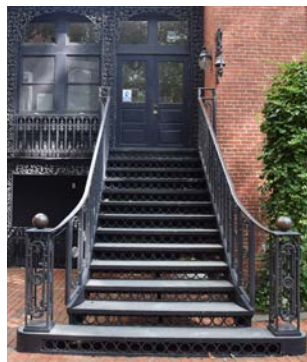
**5.64** [Lower Right] Left: Garden stair to New Orleans porch/breezeway is in good condition. Right: Handrail shows patina. [BBB, 2020]

The stair from the New Orleans porch was installed in 2008 and is in good condition but does show signs of weathering and should be cleaned and coated in the short-term.

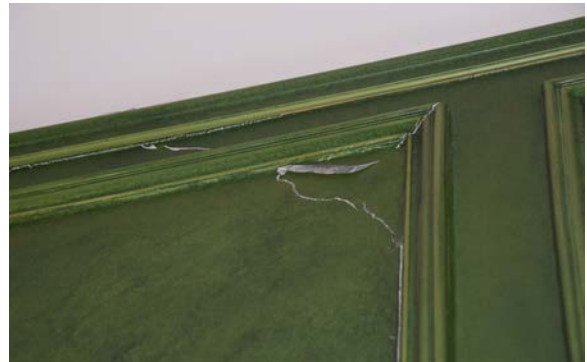
**5.67** [Left] Extensive cracking at the northeast corner of the Garden Room. [BBB, 2020]

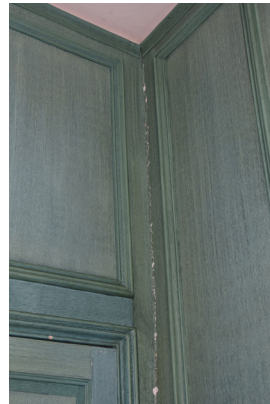
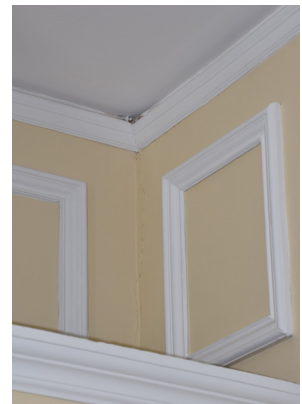
**5.68** [Right] Cracking at the wall and ceiling of the northwest corner of the southwest office on the third floor. [BBB, 2020]

**5.69** [Lower] Separation of joints at the baseboard and window jamb molding in the Garden Room. [BBB, 2020]

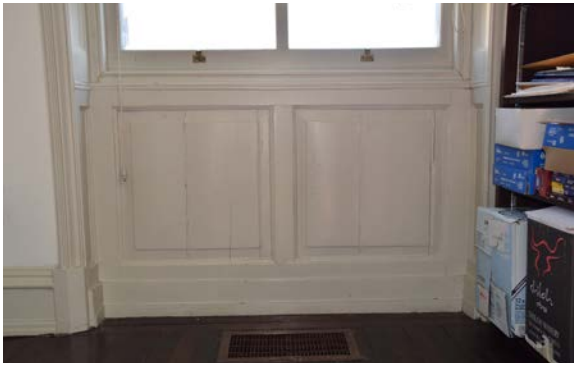
**5.70** [Top Left]  
Cracked wood panels below window in southeast corner of southeast room on third floor. [BBB, 2020]

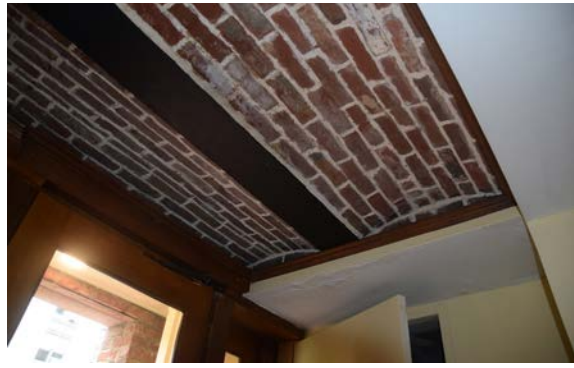
**5.71** [Top Right]  
Water damage at ceiling above business entrance. [BBB, 2020]

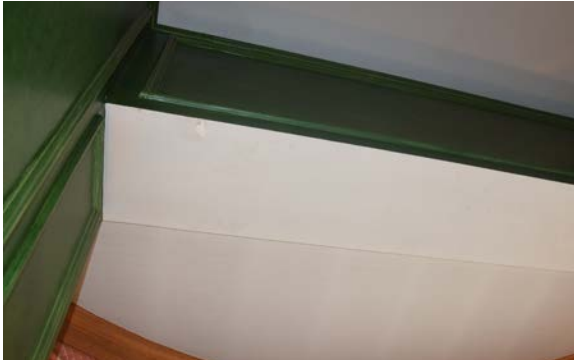
**5.72** [Lower Left]  
Peeling paint and staining from water damage at ceiling of semi-elliptical bay within the Grand Stair Hall. [BBB, 2020]

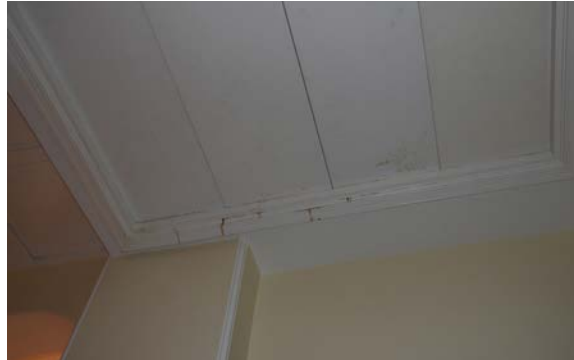
**5.73** [Center Right]  
Water staining from water damage from leaking heat pump in third floor hall. [BBB, 2020]

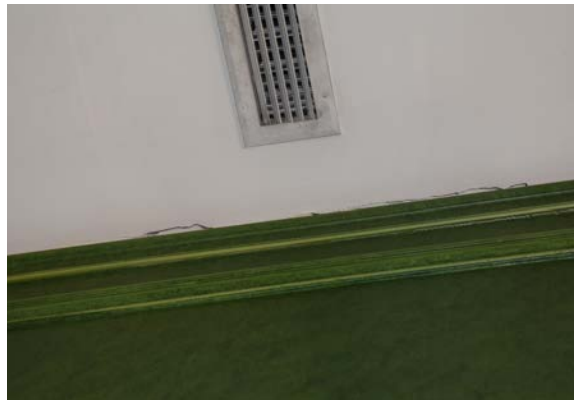
**5.74** [Lower Right]  
Cracking at ceiling in Grand Stair on second floor. [BBB, 2020]

Ceiling cracks are minimal and typically occur at the crown molding. This is especially apparent at the Grand Stair Hall.

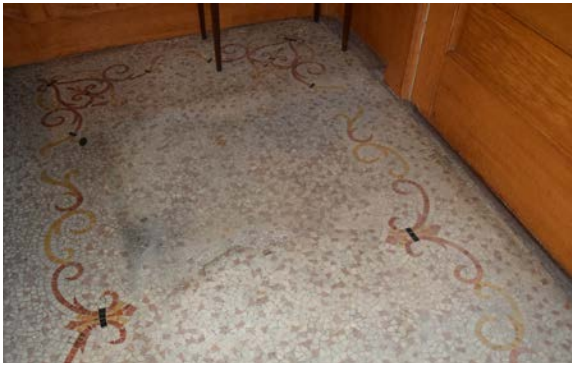
**5.76** [Top Right]  
Discoloration of grout at marble mosaic floor at entrance vestibule. [BBB, 2020]

the first floor. The mosaic floor shows some areas of soiling and discoloration, likely from dirt and moisture. A few sections have discolored grout and there is minor deterioration of the individual stones, called tesserae. Blackened chewing gum is also deposited on the floor.

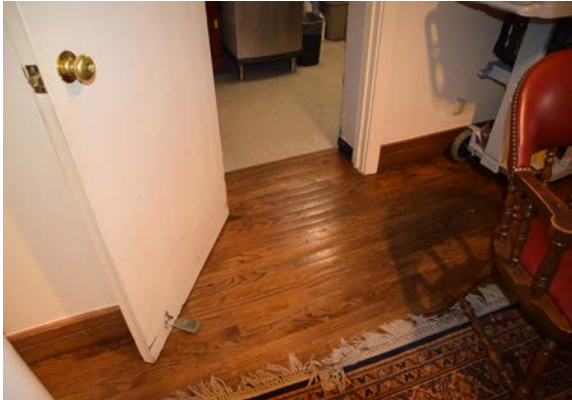
**5.78** [Center Right]  
Mechanical damage to the hardwood floors and finish in the southeast room on the third floor. [BBB, 2020]

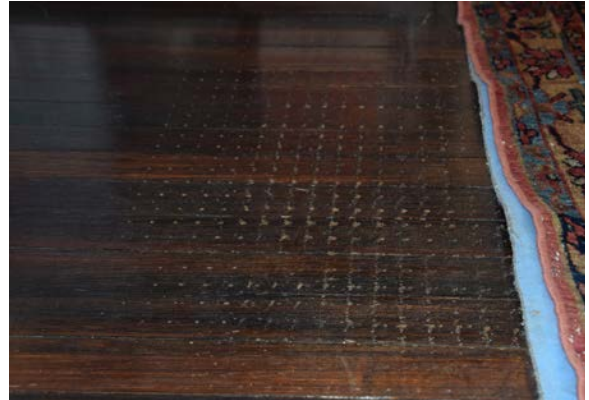
**5.79** [Lower Left]  
Loss of finish to the hardwood floors in the southeast room threshold on the third floor. [BBB, 2020]

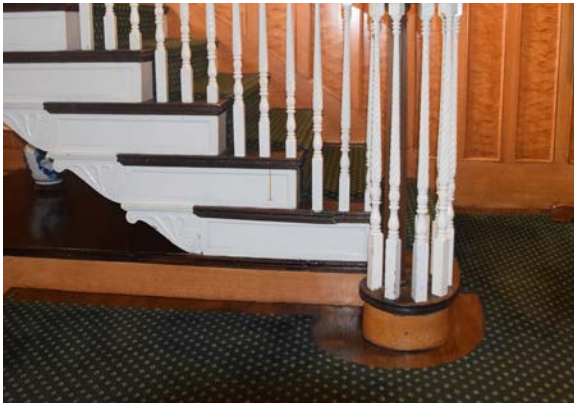
**5.80** [Top Left]  
Staining and missing paint at Grand Stair. [BBB, 2020]

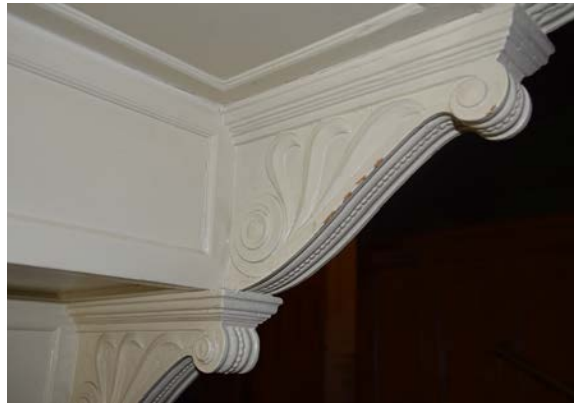
**5.81** [Top Left]  
Missing paint at Grand Stair. [BBB, 2020]

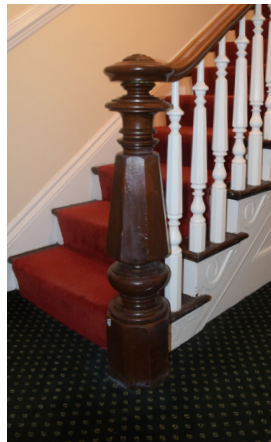
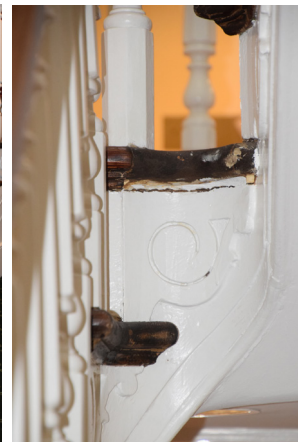
**5.83** [Center Right]  
Left: Newel post at Main Stair with a paint deposit at base. Right: Separation of joints and staining at Main Stair nosings. [BBB, 2020]

The Main Stair exhibits settlement away from the wall, which is especially noticeable at the fourth floor. There are other minor conditions such as a paint smudge on the newel post, the separation of nosing from the stair tread, and cracking at the half-turn of the stringers below the treads and nosing.

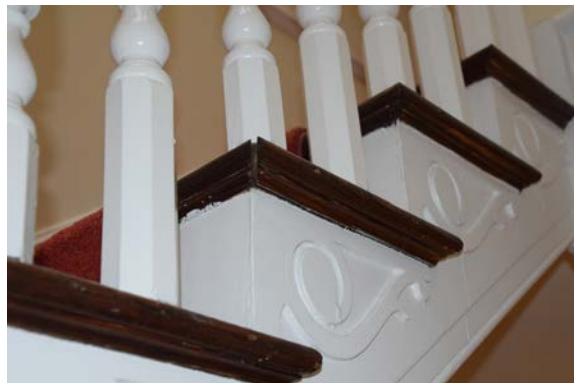
**5.84** [Lower Right]  
Separation of joints at Main Stair nosings. [BBB, 2020]

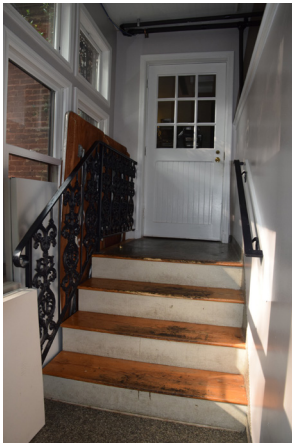
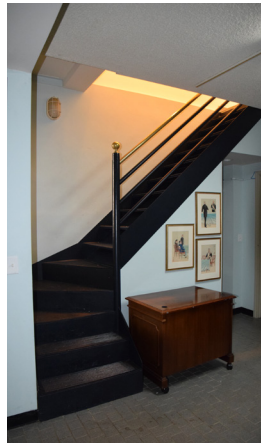
The stair in the enclosed New Orleans porch leading from the House to the Carriage House is heavily used, and its stair treads exhibit scuff marks, loss of finish, and soiling from heavy use. The painted metal stair in the Carriage House is in good condition.

**5.85** [Top Left] Left: Scuff marks and staining at stairs to Carriage House. Right: Metal stair in Carriage House is in good condition. [BBB, 2020]

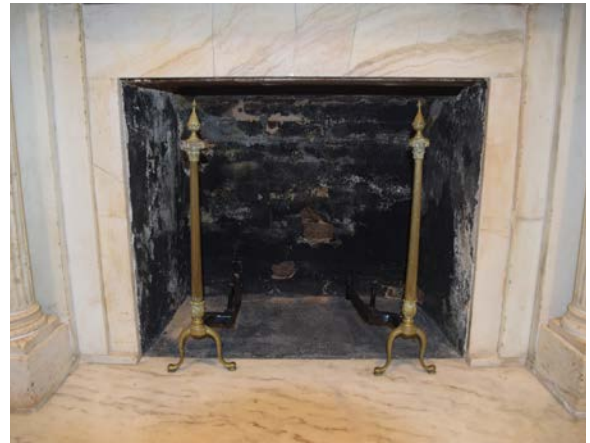
**5.86** [Top Right] Peeling and missing firebox lining at southeast fireplace on first floor (Ladies' Lounge). [BBB, 2020]

in the Library and North Dining Room remain active. Overall, the fireplaces are in good condition. The firebox opening in the Ladies' Lounge features a blackened render over the brick masonry that is deteriorating. It is lifting away from the brick and is cracked and missing in several sections. The white marble mantel shows a few cracks and areas of previous repair. On the third floor, the black marble hearth in the northwest office has many cracks and fractures through the stone, and the white marble fireplace in the northeast office on the third floor shows signs of settlement where the support for the fireplace in the floor below has weakened.

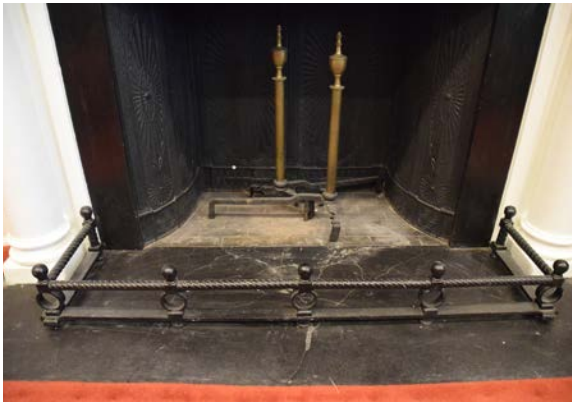
**5.87** [Lower Left] Cracking at marble hearth in southwest room on third floor. [BBB, 2020]

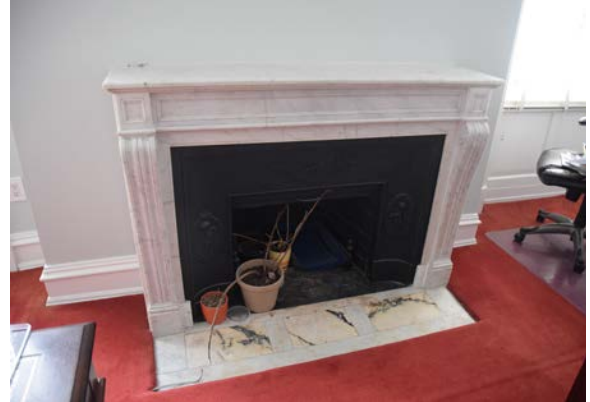
**5.88** [Lower Right] Settlement of fireplace into the floor at the northeast fireplace on the third floor. [BBB, 2020]

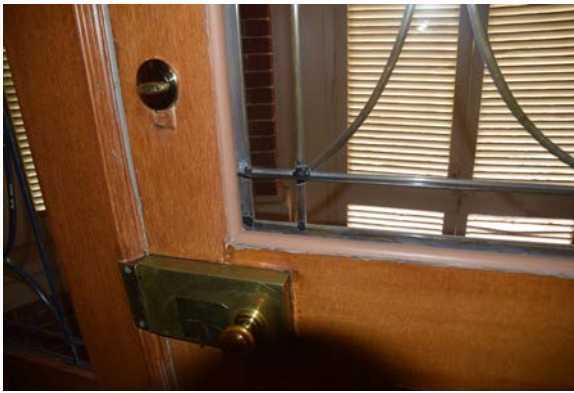
At the inside of the main entrance door, there is a bulge where an old piece of hardware below the existing lock was likely installed. The glazed panel at the entrance door is surrounded by a wood bead that is painted brown and does not match the faux wood-grained finish of the rest of the door. The door is losing its finish at the edges where it is more commonly worn. The painted finish is also wearing off at the Garden Room doors, header, and jambs and at the edges of the faux wood-grained painted doors throughout the second floor. A crack is located in the top right panel of the door leading from entrance vestibule to the Gentlemen's Lounge.

**5.89** [Top Left] Worn finish and brown painted molding at the main entrance door. Door also features a bulge below the existing lock where old hardware was likely located. [BBB, 2020]

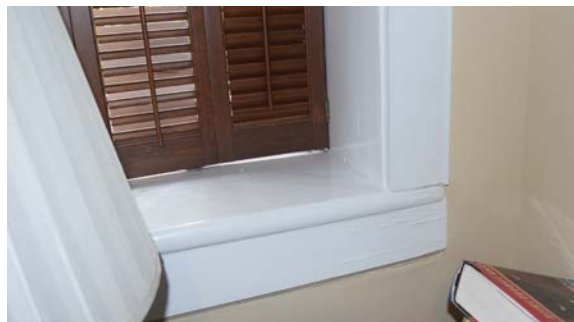
**5.92** [Center Right] Loss of profile at window stool in Library on the first floor. [BBB, 2020]

Window openings also exhibit worn and missing paint in addition to cracks, separation of joints, and loss of molding profiles. There is gouging and loss of profile at the first-floor Library window sills. The south facing window at the third-floor southeast office shows cracking and separation of joints at the header and jambs. The window surround of the tripartite window in the center third-floor office on the south wall shows loss of definition as the surround becomes flush with the wall at the top of the opening.

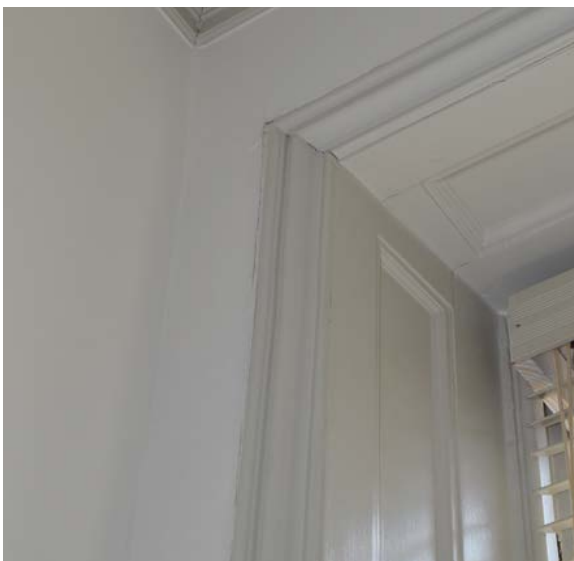
**5.93** [Lower Left] Loss of profile from settling at window surround and separation of joints at window header and jamb in south central room on third floor. [BBB, 2020]

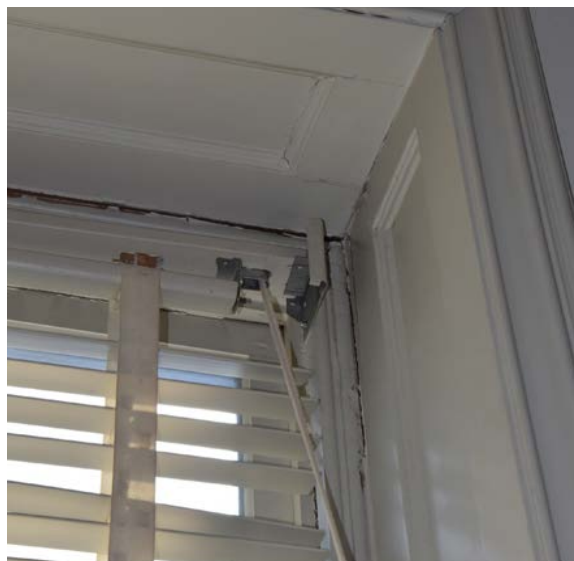
**5.94** [Lower Right] Separation of joints at window header and jambs of south facing window in south-east room on third floor. [BBB, 2020]

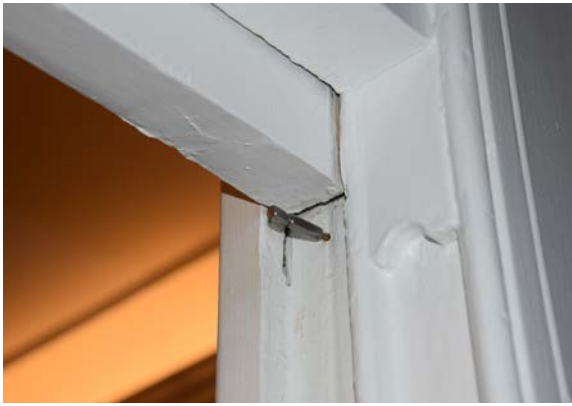
**5.96** [Top Right]  
Crack in panel  
at door from  
entrance vestibule  
to the Gentlemen's  
Lounge. [BBB,  
2020]

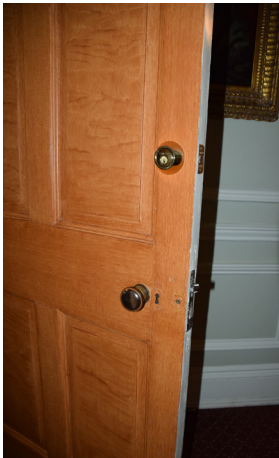
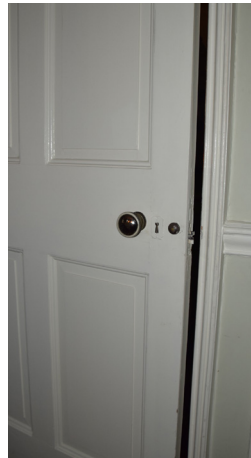
**5.97** [Lower Left]  
Left: Door from  
Grand Stair Hall  
to North Drawing  
Room features  
modern lock.  
Right:  
A typical door on  
the second floor  
with locking mech-  
anism to the right  
of the knob. [BBB,  
2020]

The door and window hardware is in overall good condition, however, there are some damaged or missing pieces and door hardware is inconsistent. For example only the door from the Grand Stair Hall to the North Drawing Room features a modern lock set above the knob. The other doors feature a locking mechanism immediately to the right of the knob, which may be locked from inside the respective second floor rooms. Most door knobs are brass, but the inside knob of the door to the Garden Room is colored glass.

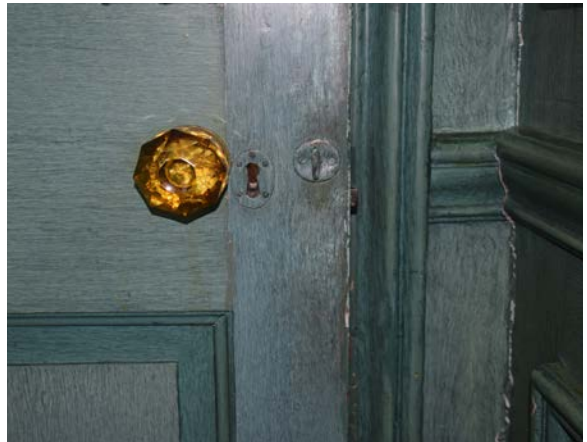
**5.98** [Lower  
Right] Colored  
glass doorknob  
at Garden Room.  
[BBB, 2020]

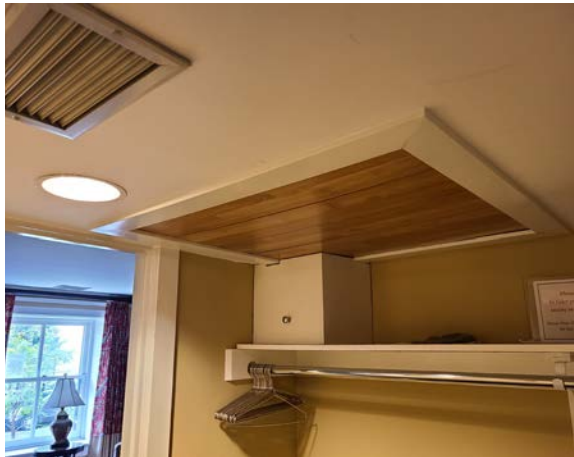
The House is served by several water-source heat pumps which were originally installed circa 1986. They are generally concealed above ceilings with access panels to facilitate service. Generally, concealed supply and return ductwork connect the water source heat pumps to air devices mounted in walls and ceilings. With the exception of Unit #10, which once served a kitchen, the units are not provided with outside air. Heat pumps have been replaced as they fail. The average age is approximately 6 to 8 years old. The following table is a list of the water-source heat pumps, and the associated areas served. The expected remaining life of the heat pumps varies with age. As a group, their condition requires semi-continuous replacement of units as they fail. Presently, three units are non-functional.

5.99 [Left] Heat pump in ceiling at coat room in Gentlemen's Lounge.

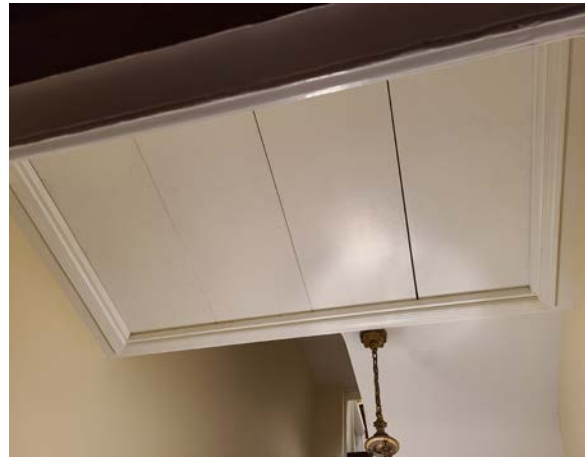
5.100 [Right] Heat pump in ceiling at Main Stair Hall.

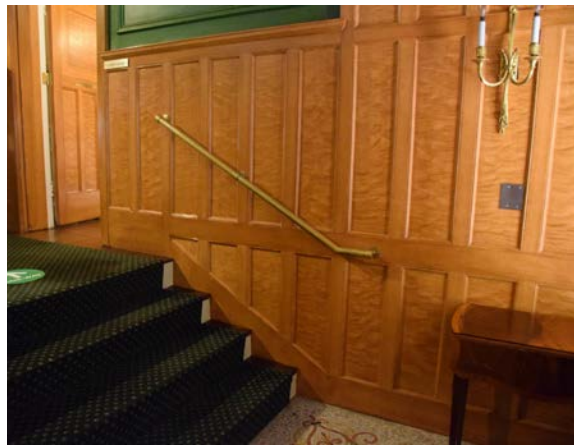
ADA-compliant handrails measure between 34 and 38 inches in height. The accessible handrail leading from the entrance vestibule to the first-floor landing at the Grand Stair Hall is 36 inches high and is ADA compliant. The historic handrail height at the Grand Stair is 28 ½ inches, the historic handrail height at the Main Stair is 29 inches, and the handrail height in the fire stair is 32 inches.

**2.6** [Right] ADA-compliant handrail at the front vestibule. [BBB, 2020]

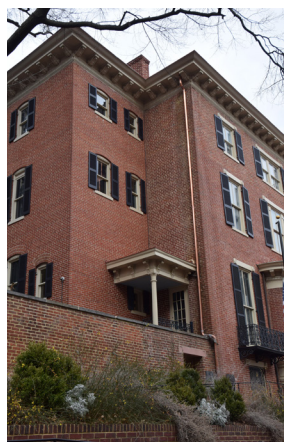
**3.2** [Left] New copper downspout at the southwest corner of the House. [BBB, 2021]

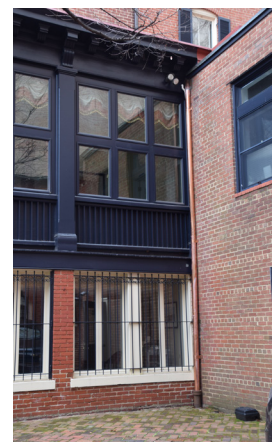
**3.3** [Left] New copper downspout from the porch roof at the northwest corner of the House. [BBB, 2021]

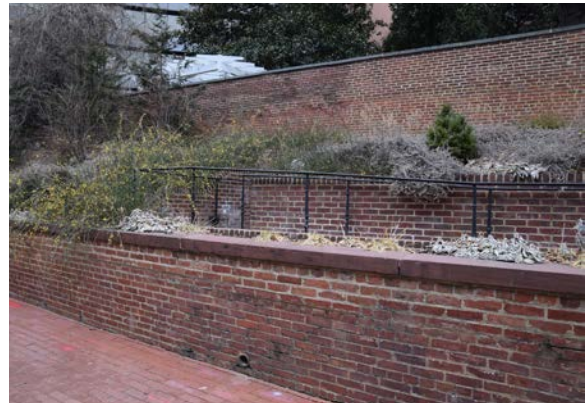
**3.5** Bowing of the south Garden wall. [BBB, 2021]

Garden Walls	Very Poor	<b>Serious to Critical</b> (1-2 yrs)	<i>Condition:</i> Deflection, cracking, and loss of mortar are affecting the structural integrity of the walls, especially at the southwest corner. <i>Recommendations:</i> Consult a structural engineer to address bowing and structural vulnerability of the Garden wall. Pinning or and addition of buttresses may be required to support the structure, especially along the south wall and at the northwest corner. Repoint the wall and reset displaced coping stones with new mortar. Ensure horizontal, skyward facing joints at coping stones are maintained with mortar. Consider addition of a lead T-cap at these joints.	Continue to monitor condition.
Front Paving	Fair	<b>Serious to Critical</b> (1-2 yrs)	<i>Condition:</i> Chipping and blistering of paving stone at front entrance; biological growth at brick paving to left of entrance bay. <i>Recommendations:</i> Remove the unattached blistered and scaled area of the paving stone in front of the entrance with hand tools. Tool stone so that water doesn't pool. Another option may be to lift and flip the paving stone, resetting in situ. To address the biological growth and drainage issues at the west side of the entrance bay see recommendations above in "Site Drainage."	Continue to monitor condition of pavers.

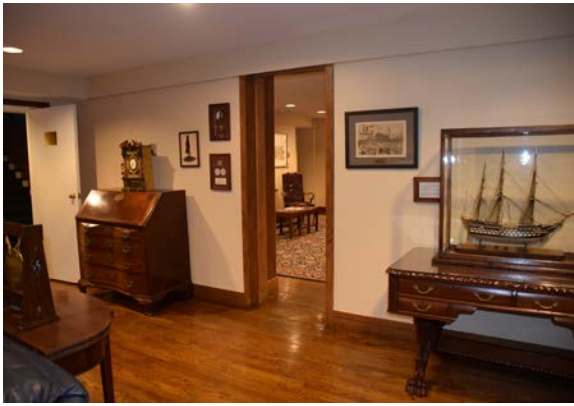
**3.7** [Top Left] Narrow doorway between the Meeting Room and Library may be widened to improve circulation. [BBB, 2020]

4. The opening between the Meeting Room and the Library is 30", which is very narrow and may be widened to the north to ease circulation and make the rooms more accessible. The existing pocket door may be removed and a new door frame and door installed.
5. To ease congestion and increase circulation from the first floor to the Garden, the windows in the north alcove of the Meeting Room may be converted to one or two double doors that open out to the courtyard.

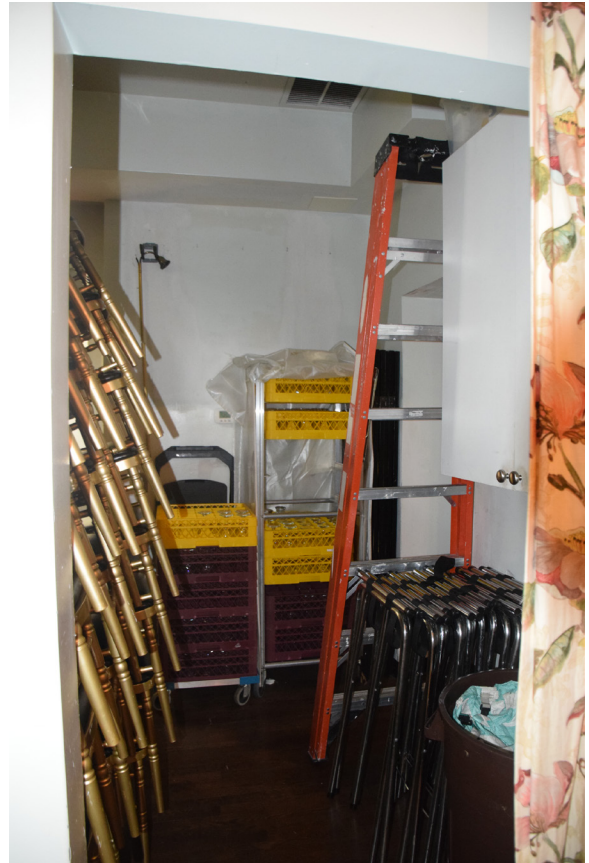
**3.11** [Right] Storage room behind the Dining Room limits circulation from the Garden and Gallery to the restrooms on the first floor. [BBB, 2020]
