Chapter 5: Existing Conditions 2024 Update

This chapter describes the existing conditions of the DACOR Bacon House as of July 2024. It is intended to be an update to the 2021 HSR condition survey, completed in October 2020, and consists of an existing condition summary matrix, a list of recommended priority treatments, condition photographs, and updated floor plans and elevations that note areas of deterioration.

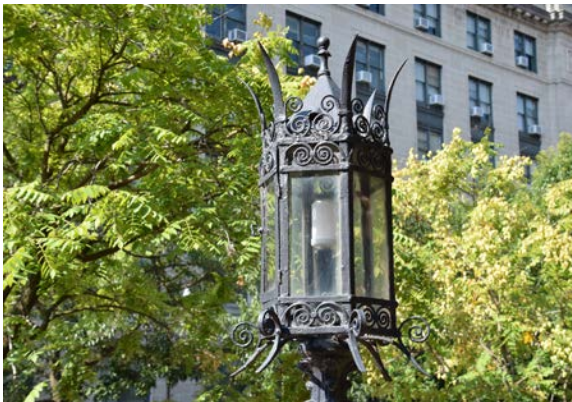
Fig. 16 [Lower
Left] Wrought iron
lantern latches
have been repaired.
Iron work should
be monitored and
spot painted as
needed. [BBB,
2024]

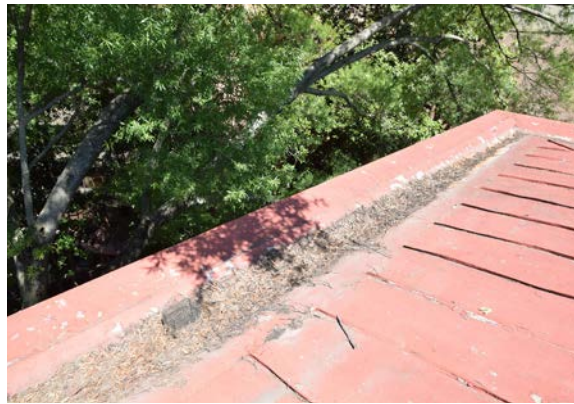
Fig. 18 [Top Right]
West edge of the roof with new strainer box. [BBB, 2024]

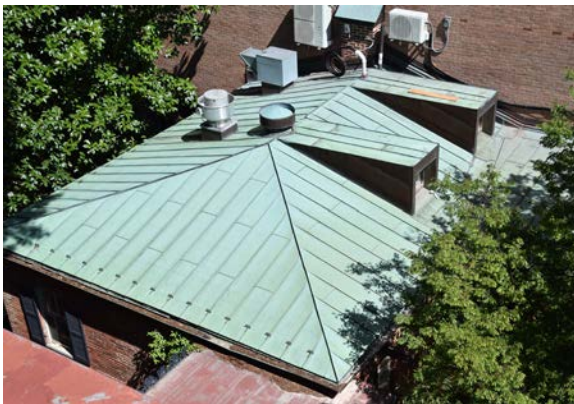
Fig. 21 [Left] Carriage House roof view from Main House. [BBB, 2024]

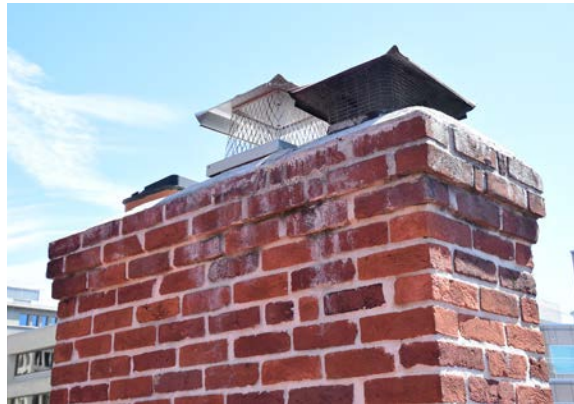
Fig. 22 [Right] Southeast chimney with new caps. [BBB, 2024]

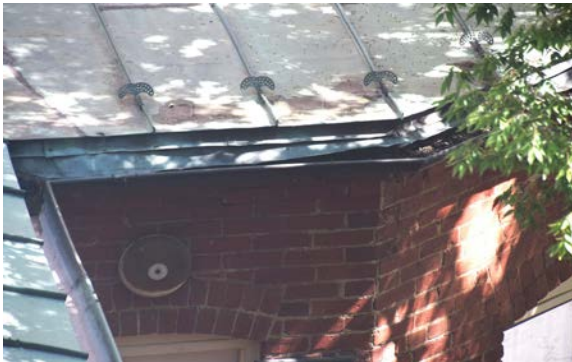
| Building/Site Element | Figures | Condition Rating | Priority Rating | Explanation/Condition Summary and Recommended Treatment(s) |
|---|--|---|---|--|
| Gutters | Fig. 27 Fig. 28 | Fair | Minor to Serious | <p>See roof conditions for discussion on gutters at main roof and front entry roof. Copper gutters at the Carriage House and the breezeway exhibit bending and displacement</p> <p><u>Recommended Treatment(s):</u> Inspect copper gutters and fasteners at the Carriage House and breezeway. Use rubber mallet to repair dents or reshape and refasten as needed. A roof and gutter specialist may recommend replacement of the breezeway gutter as that one appears most damaged. Consider replacement occur simultaneously with treatment to breezeway roof.</p> |

Fig. 28 [Right]
Bent gutter and
displaced fasteners
at breezeway.
[BBB, 2024]

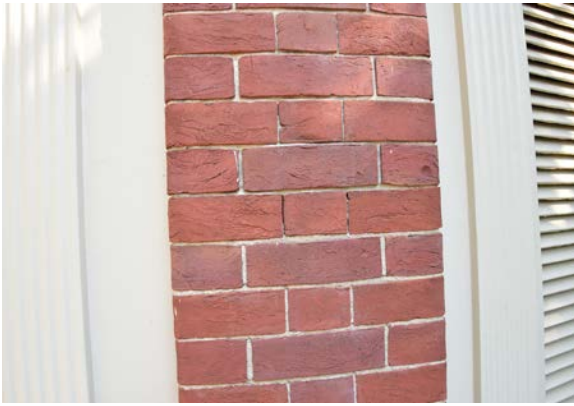
| Building/Site Element | Figures | Condition Rating | Priority Rating | Explanation/Condition Summary and Recommended Treatment(s) |
|---|---|---|---|--|
| Masonry Walls | Fig. 29 Fig. 30 Fig. 31 Fig. 32 Fig. 33 Fig. 34 Fig. 35 Fig. 36 Fig. 37 | Fair to Poor | Minor to Serious | <p>Overall good condition. There are areas of brick masonry that exhibit open joints, step cracking, fractured bricks, and efflorescence or staining. Stone masonry is used primarily at the window sills and lintels and at the main entry bay. Stone elements exhibit erosion/natural weathering and cracking.</p> <p><u>Recommended Treatment(s):</u> Conduct masonry repairs pertaining to each condition. Repoint areas where there are open joints, including the south façade below the third floor tripartite window and the area on the north façade, below the first floor windows. Raking of joints should be done with hand tools only, and care should be taken especially at the front entrance bay to ensure the fine mortar joints between the pressed bricks are maintained. There are several areas where step cracks occur, especially on the east façade. A structural engineer should be consulted or the step cracks and the fracture crack at the lintel on the south façade. Joints should be raked out at the crack and 12" of the crack on either side by hand. Install horizontal stainless steel reinforcement rods at joints and replace any bricks with fracture cracks. The failing patch on the lintel at the Carriage House should be removed and repatched with restoration mortar. See 2021 HSR Part 2 Chapter 3 for further recommendations.</p> |

Fig. 33 [Top Left]
Open joints at
pressed brick at
front entrance bay.
[BBB, 2024]

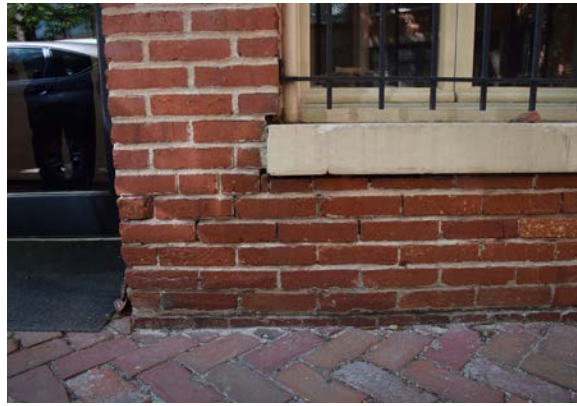
Fig. 34 [Top Right]
Open joints at
brick below meet-
ing room window
on north façade.
[BBB, 2024]

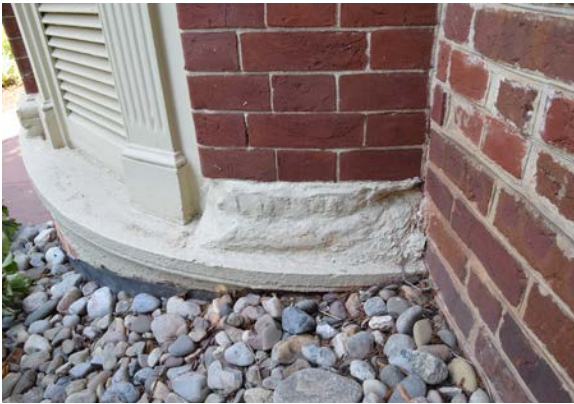
Fig. 35 [Left]
Sandstone at front
bay exhibits ero-
sion and should be
monitored. [BBB,
2024]

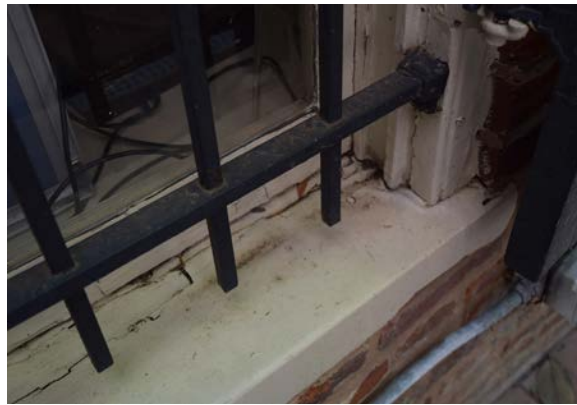
| Building/Site Element | Figures | Condition Rating | Priority Rating | Explanation/Condition Summary and Recommended Treatment(s) |
|---|---|---|---|--|
| Windows | Fig. 38 Fig. 39 Fig. 40 | Fair to Poor | Serious | <p>Seal failure of double-glazed windows resulting in fogging of glass; deteriorated finish/peeling paint and checking at several window sills and lintels (especially on east façade); rotten window elements at first floor window on west façade of Carriage House; broken or missing louvered shutters. Several of the north porch windows are missing exterior trim pieces.</p> <p><u>Recommended Treatment(s):</u> Consult with window companies to replace non-historic wood windows with double-glazing in kind, matching existing window muntins and profiles. Replace sills with major checking; strip, sand, repair, and repaint sills with minor checking or deteriorated finish. Restore window frames and wood window lintels. Replace the entire window unit on the first floor of the west façade of the Carriage House. Repair wood shutters. Replace non-historic wood trim at north porch windows. See 2021 HSR Part 2 Chapter 3 for further recommendations.</p> |

Fig. 38 [Right]
Rotten window sill
on the first-floor
window on the
west façade of the
Carriage House.
[BBB, 2024]

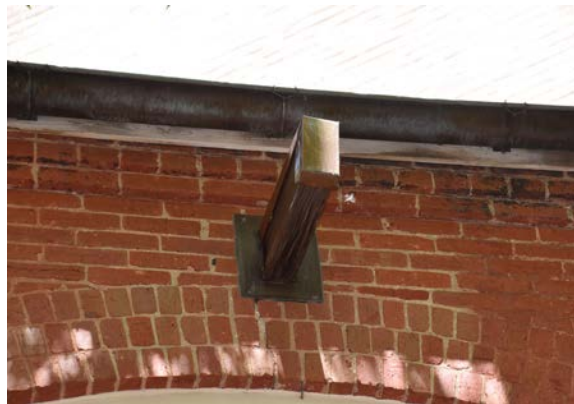
| Building/Site Element | Figures | Condition Rating | Priority Rating | Explanation/Condition Summary and Recommended Treatment(s) |
|---|---|---|---|--|
| Wood Hoisting Beams | Fig. 51 | Good | Not Rated | Wood hoisting beams are covered and protected with copper coping. <u>Recommended Treatment(s):</u> N/A |

Fig. 51 [Lower Right] Newly installed copper flashing protects wood hoisting beams at Carriage House. [BBB, 2024]

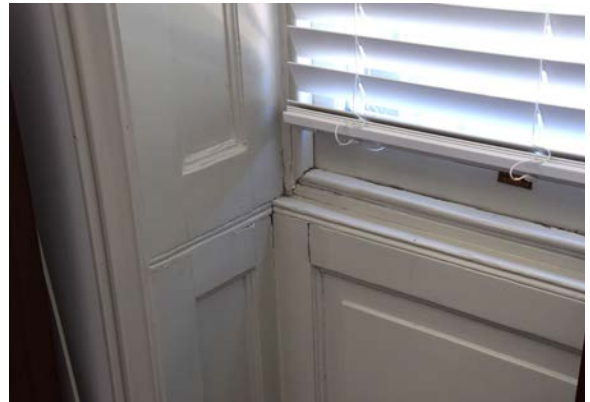
| Building/Site Element | Figures | Condition Rating | Priority Rating | Explanation/Condition Summary and Recommended Treatment(s) |
|---|---|---|---|---|
| Interior Door and Window Elements | Fig. 53 Fig. 57 Fig. 73 Fig. 74 Fig. 75 | Fair | Minor | <p>Loss of paint, joint separation especially at headers and jambs, cracking, loss of molding profile, mechanical damage, damaged or inconsistent hardware.</p> <p><u>Recommended Treatment(s):</u> See 2021 HSR Part 2 Chapter 3 for recommendations to treat joint separation. Split panels at window aprons on third floor should be replaced in kind. Repair and repaint damage to head of pocket door opening between the dining room and north parlor. See 2021 HSR Part 2 Chapter 3 for further stair treatment recommendations. Recommend treatments to interior window elements as windows are replaced.</p> |

Fig. 74 [Center Right]
Separation of joints at window apron on third floor. [BBB, 2024]

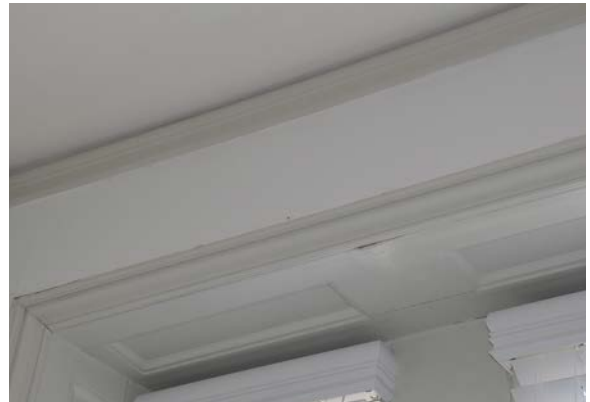
Fig. 75 [Lower Right]
Loss of finish and separation of joints at window opening in center office on third floor. [BBB, 2024]

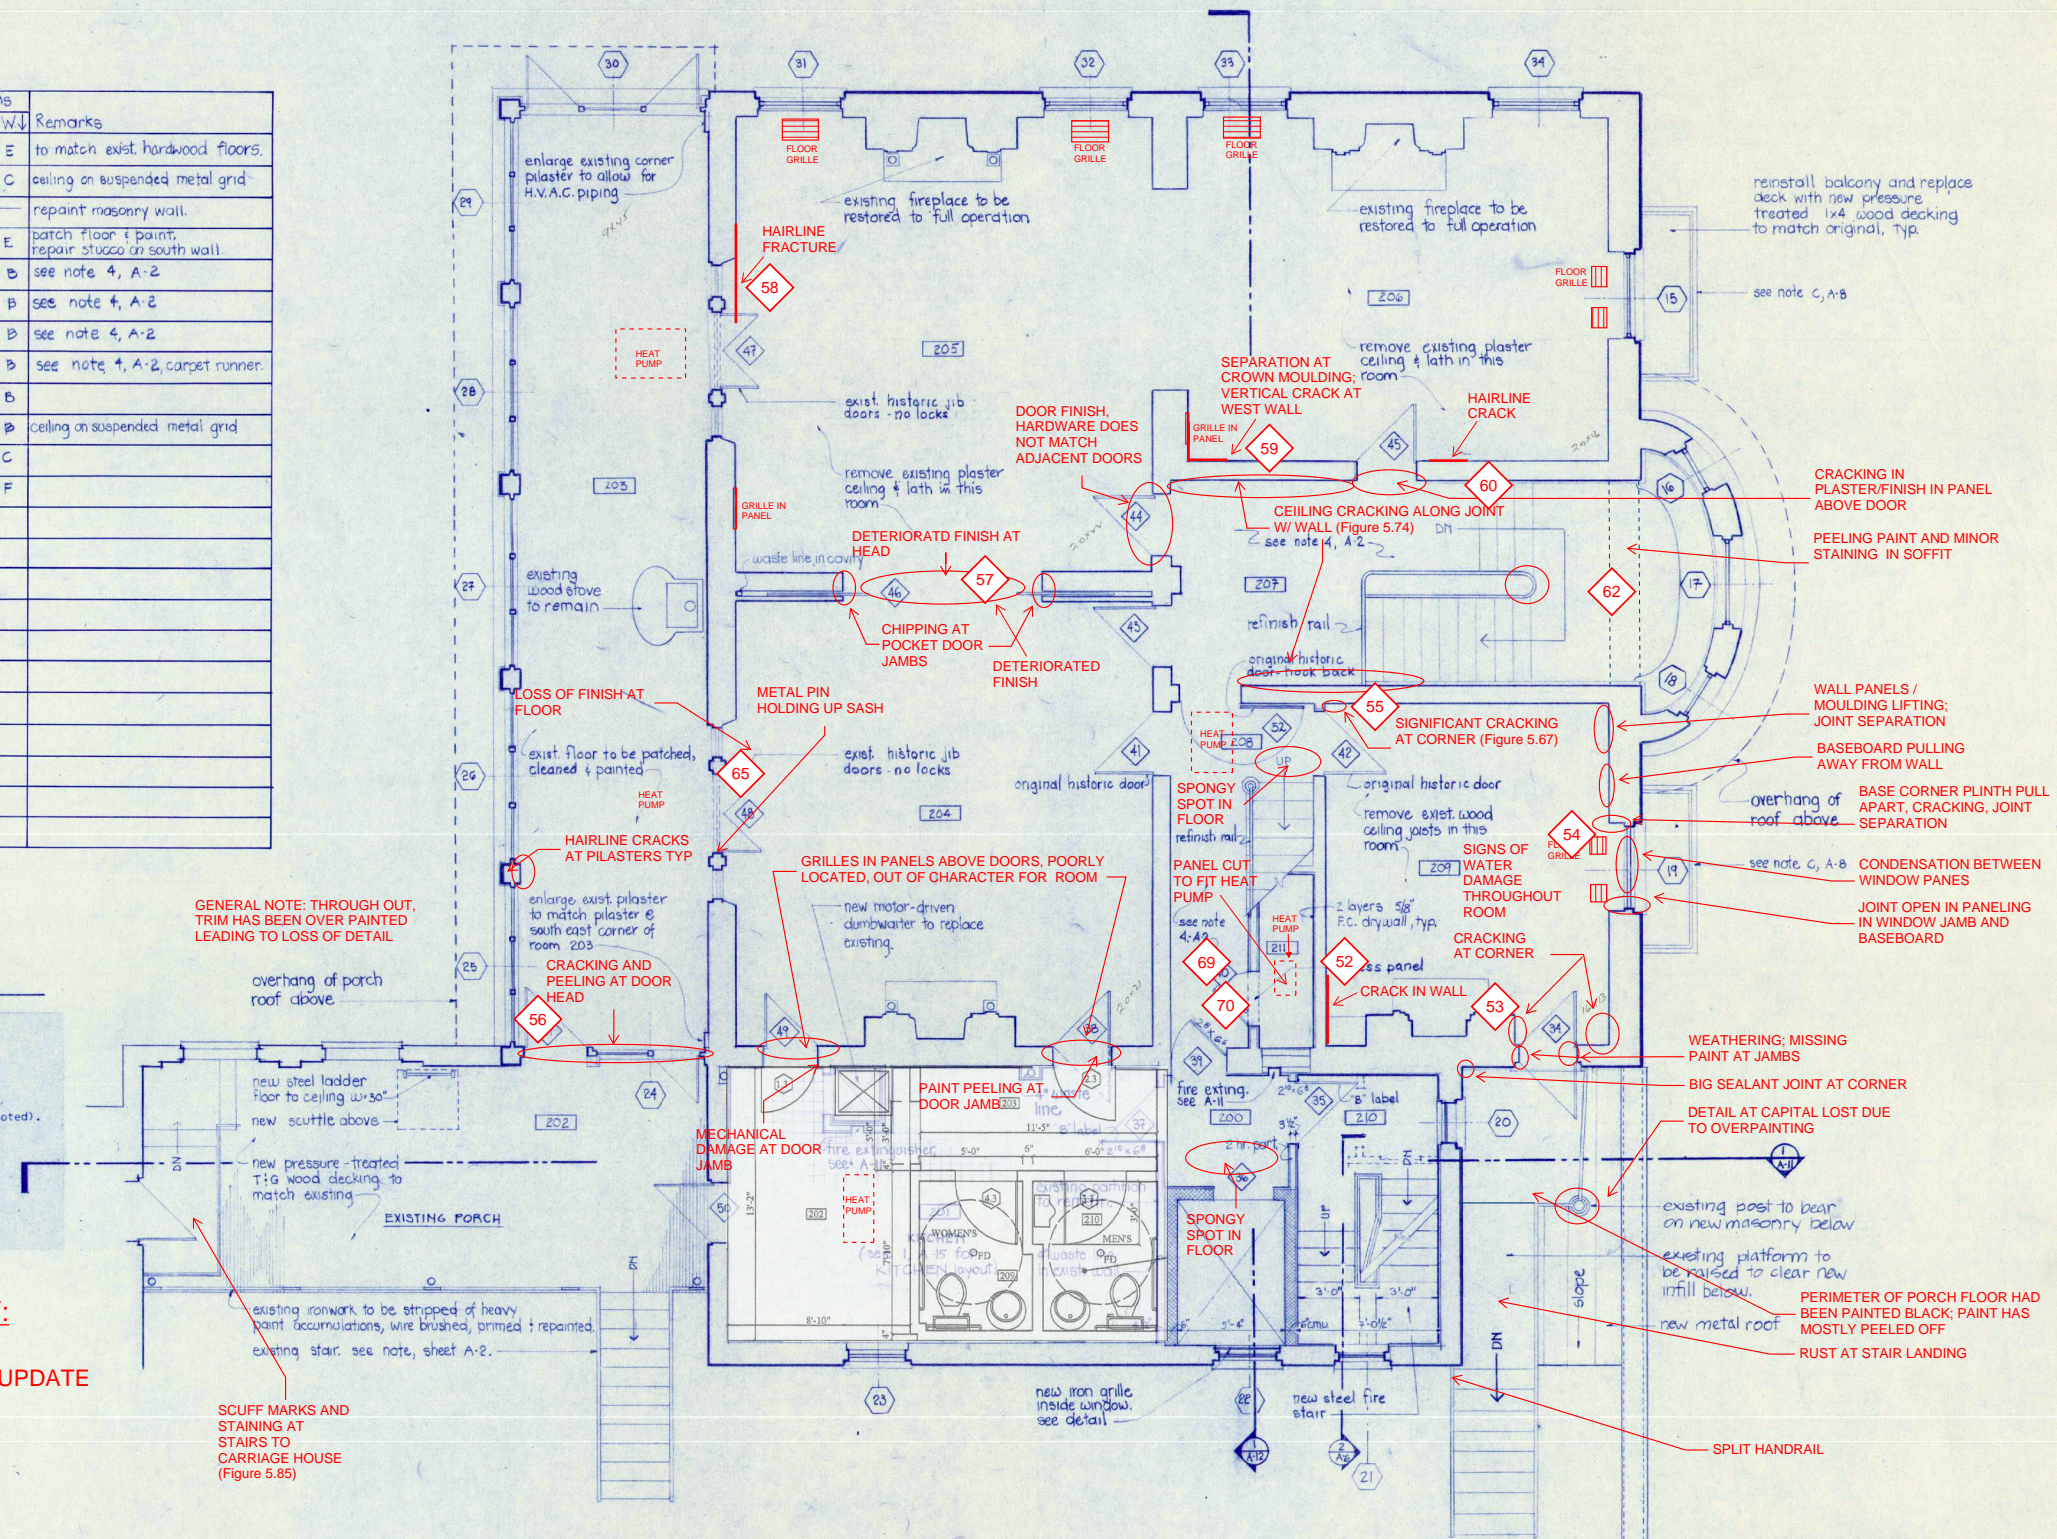
SCUFF MARKS AND STAINING AT STAIRS TO CARRIAGE HOUSE (Figure 5.85)
